SIEMENS  
HEBER SPRINGS,  
ARKANSAS

FACILITY ASSESSMENT

| <b>PROJECT</b> | Siemens Power Transmission and Distribution, Inc.<br>Heber Springs, AR<br>Facility Assessment |
| <b>DATE</b> | 10/10/2025 |

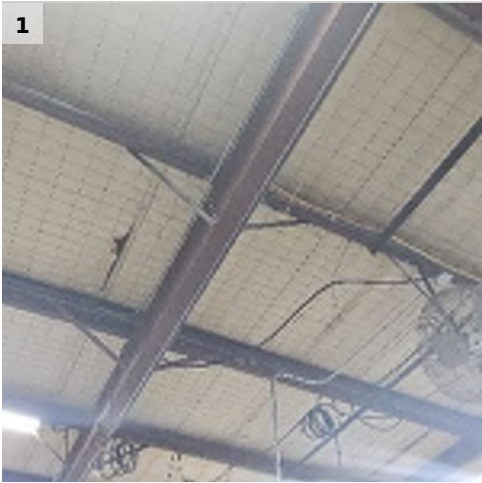
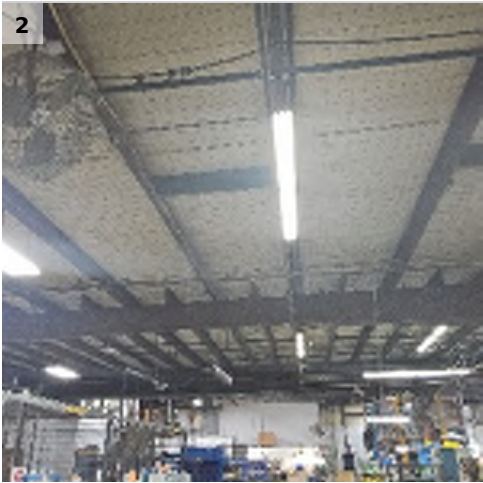
#5 - Standard PEMB insulation

2. The building was originally designed as a non-conditioned space and areas have since been air-conditioned and there is a desire to air-condition additional areas. It is recommended to upgrade the building insulation to a higher-performing product such as the Simple Saver system. In addition to reducing energy costs and improving occupant comfort, a Simple Saver system, due to its white color, will brighten the factory space and potentially improve the performance of the lighting system.

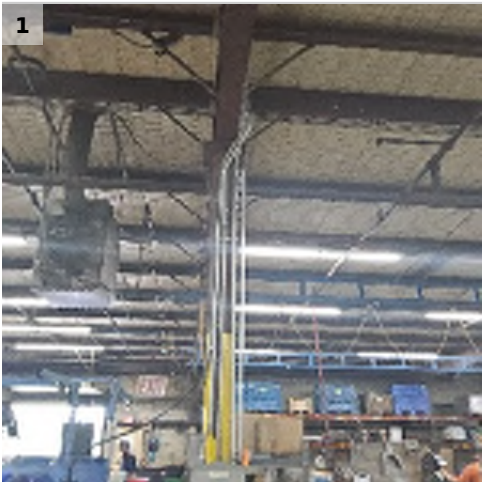
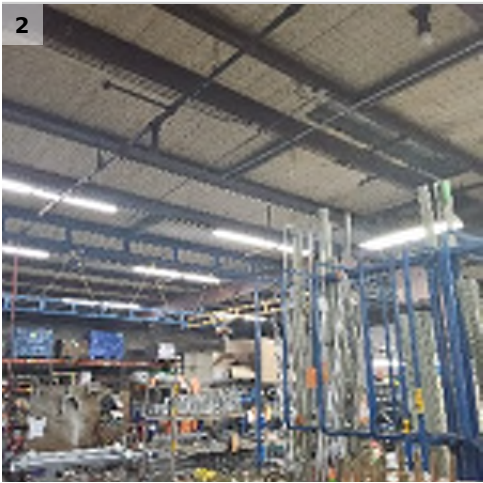
#6 - Crane is attached to PEMB structure

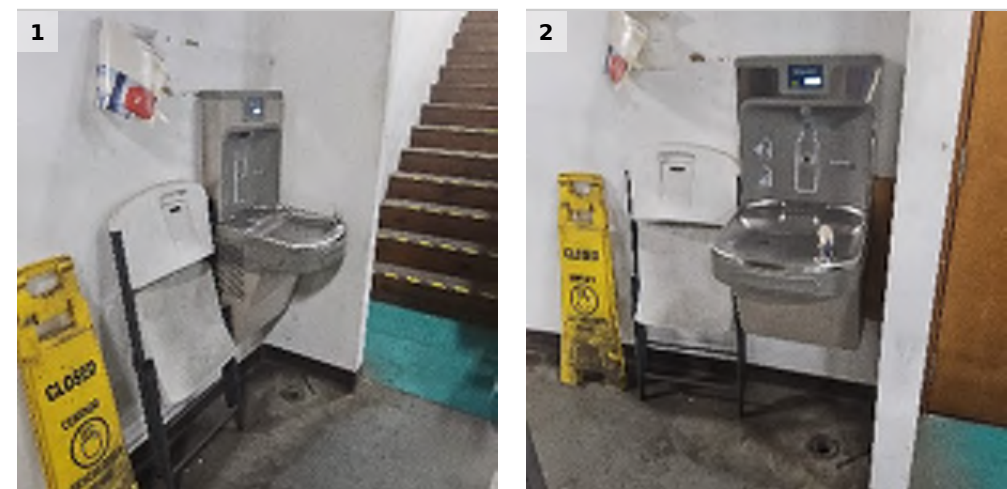
**#10 - Drinking Fountain**

| Kennedy Lockhart | Code required (2) fixtures, will AHJ allow this to count as 2? | 27 Jun 06:36 AM |

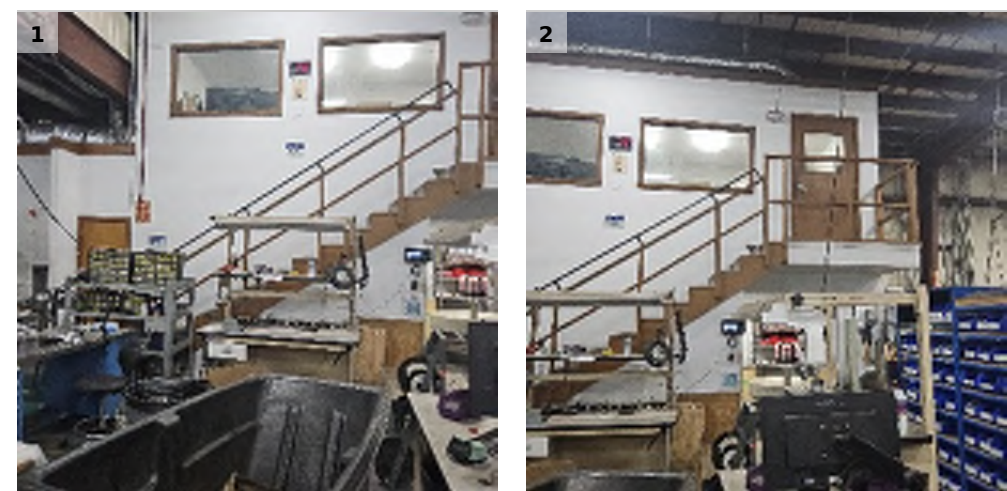
13. The existing guardrail up to the mezzanine is non-code compliant
14. Access gate in the Break Room/R&D and Engineering room is non-code compliant.
15. Only one drinking fountain was observed.
16. A mop/utility sink was not observed.
17. The Maintenance building windows leak around the seals, and the overhead door is not properly sealed at the bottom. Refer to #28 in **Exhibit A - Field Report**.

#11 - Non compliant guardrails

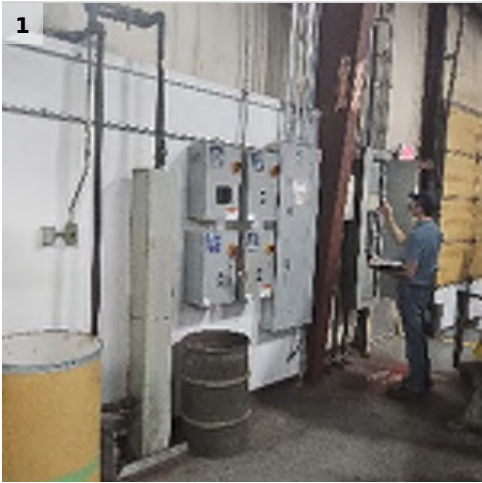
#13 - Electrical Service

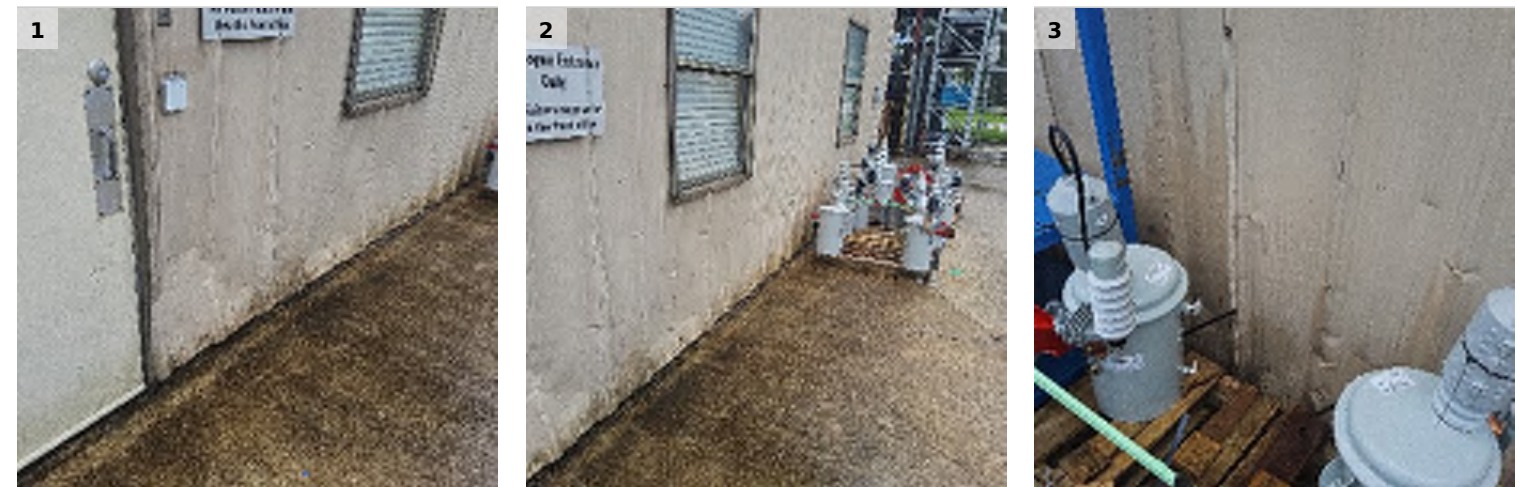
3. Significant damage to the exterior metal panels was identified on the east side near the fork lift ramp.
4. Rust damage was observed on the exterior metal panels on the southeast corner of the building near the loading dock doors. It was stated by the Business Unit that this location is where water leaks occur in the walls. Flashing has been installed underneath the panels to help with the leaking, but leaking still persists. Near this flashing repair is where rust damage was noticed.

#19 - Exterior metal panels are damaged

1. Replace the damaged metal panels located on the east side by the fork lift ramp to better insulate and waterproof the building. Install bollards or other protective measures to help protect the metal panels from future damage.

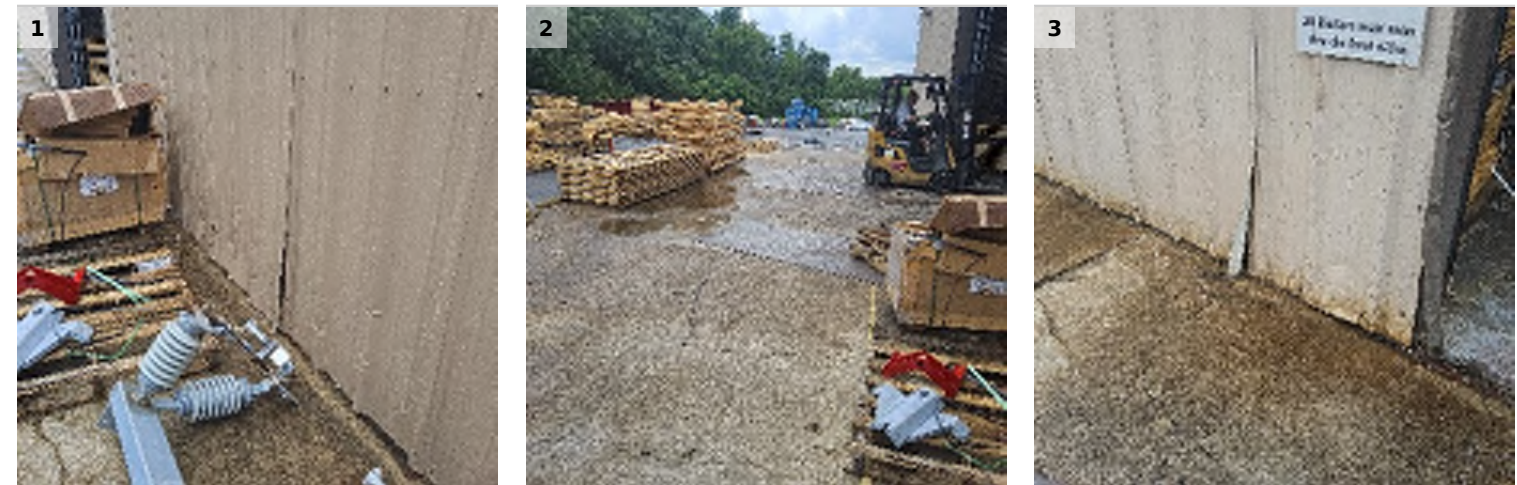
#20 - Exterior Panels Damaged

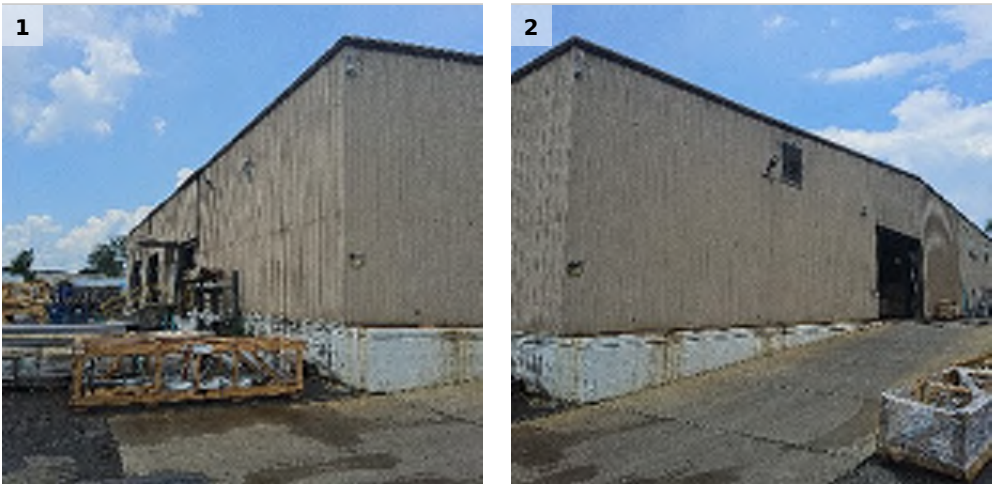
#21 - Exterior panels damaged

| Kennedy Lockhart | Area leaks at bottom of wall | 27 Jun 06:40 AM |

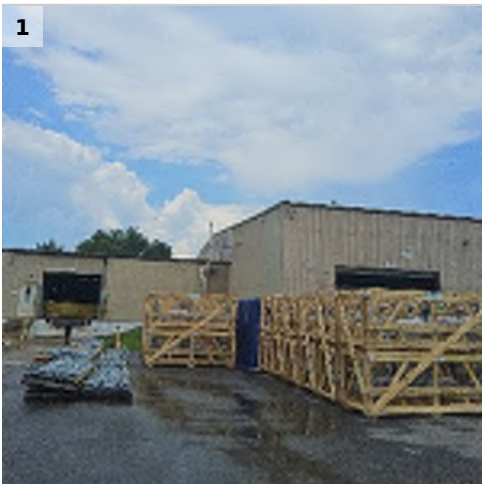
5. Gutters are not continuously installed around the building.
6. There is roof leakage where the low roof meets the vertical face of the taller factory space in the north bay. The exterior wall is covered in membrane roofing material. Refer to #22 in **Exhibit A - Field Report**.

#22 - Vertical part of wall is covered in membrane roofing

4. Remove and infill the wall exhaust fans in the Factory to seal and insulate the envelope in preparation for air-conditioning.
5. Remove any membrane roofing, identify and fix roof leaks, and flash around all openings, joints, expansions, etc. with appropriate SMACNA details.

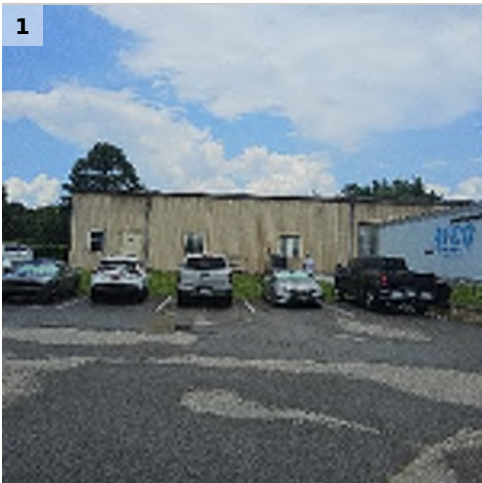
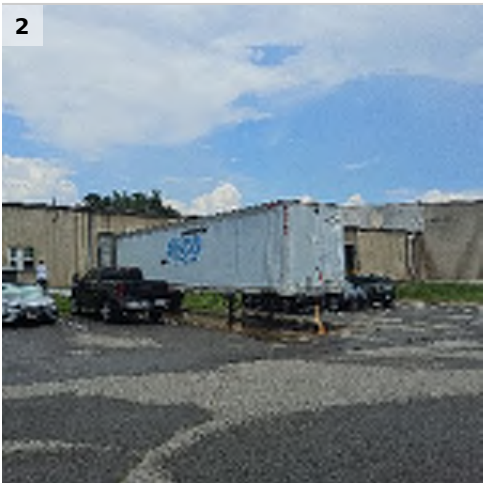
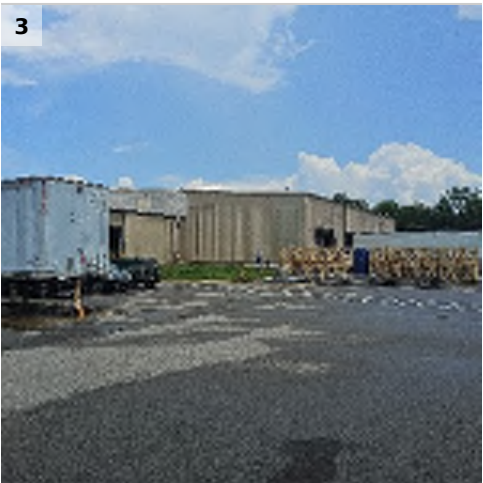
#23 - Gutters only occur over doors

| Kennedy Lockhart | Gutters only occur over doors | 24 Jun 11:40 AM |

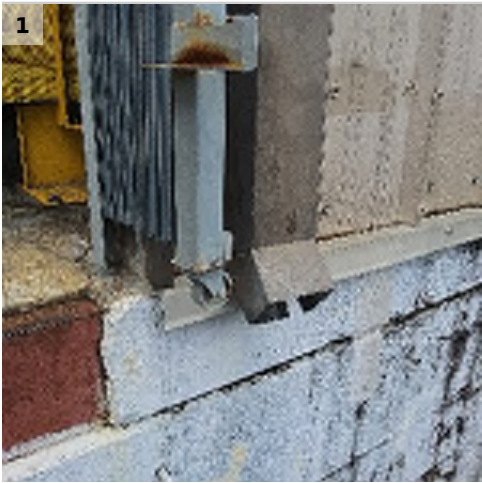
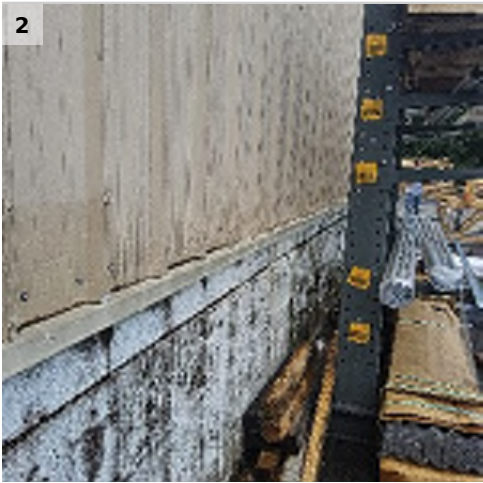
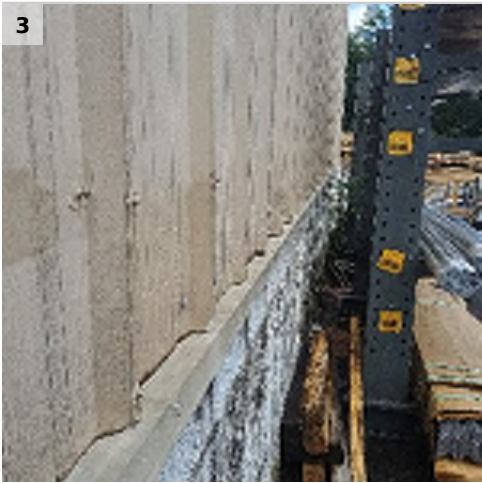
**#24 - Wall leaks**  
Priority 2 | Kennedy Lockhart | -  
Plan: HS Plant Layout

| Kennedy Lockhart | Wall leaks | 24 Jun 11:48 AM |

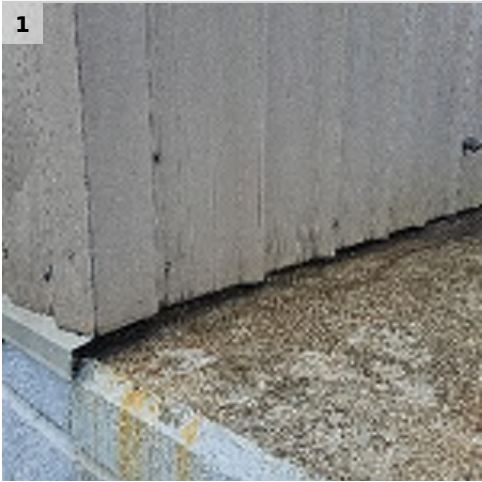
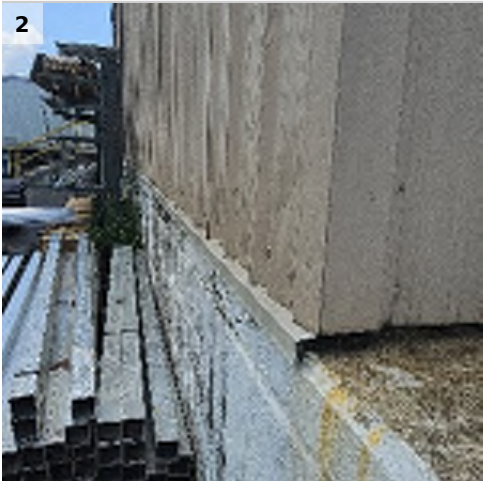
**#25 - Wall leaks**  
Priority 2 | Kennedy Lockhart | -  
Plan: HS Plant Layout

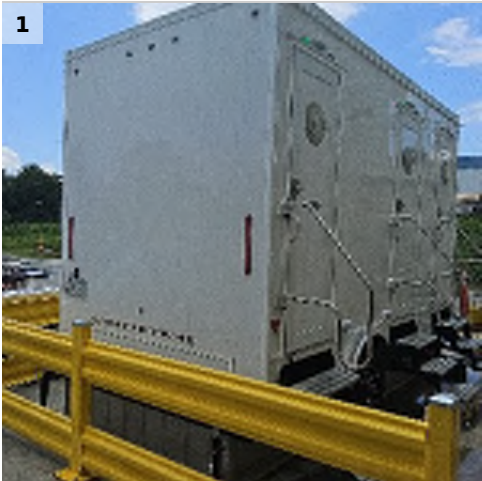
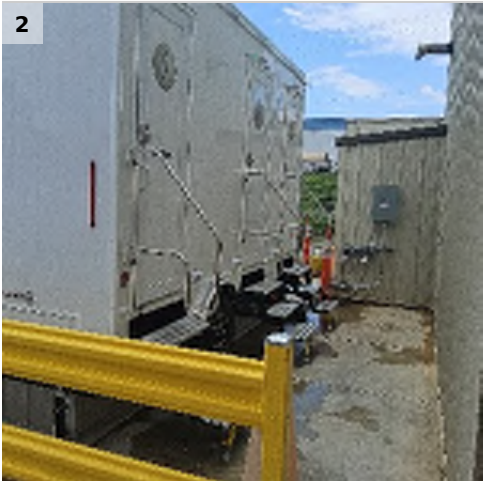
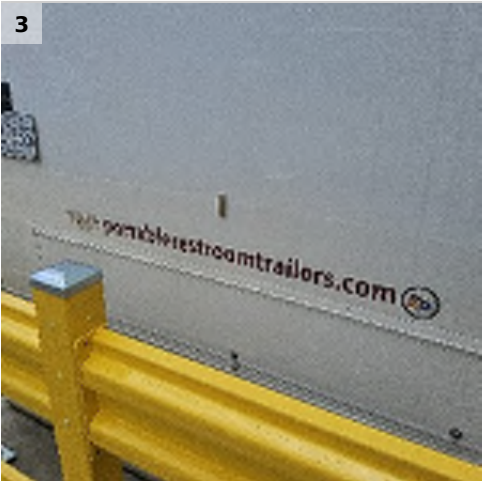
**#27 - Portable restrooms are non compliant**

| Kennedy Lockhart | Portable restrooms are non compliant | 24 Jun 11:55 AM |

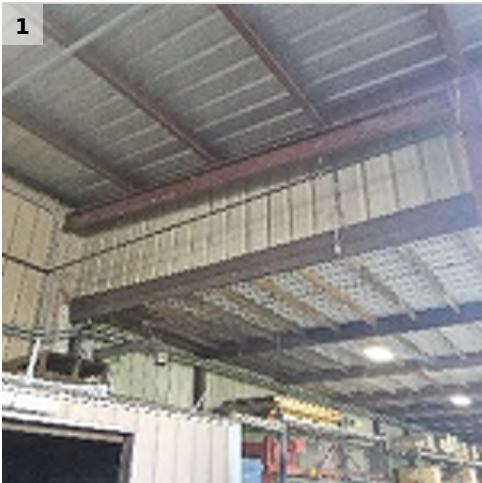
**#29 - Lean to transitions from steel framed (higher roof) to wood framed (lower roof)**

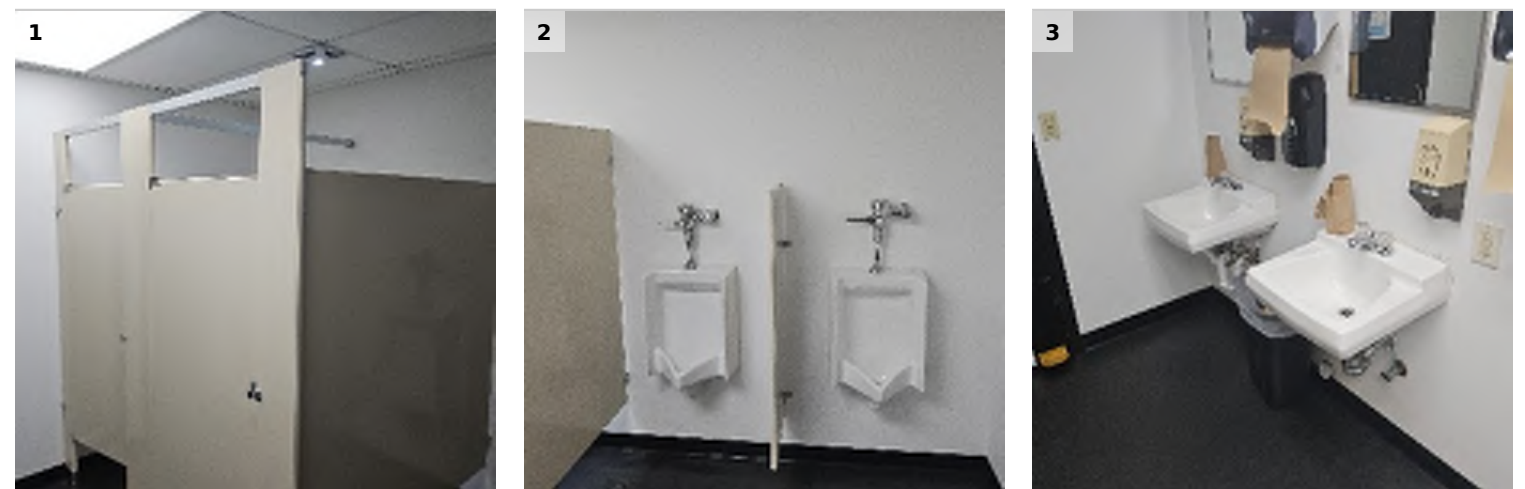
**#30 - Restroom is non compliant**

| Kennedy Lockhart | Restroom is non compliant | 24 Jun 12:16 PM |
