ARCHITECTURAL FINISHES & MATERIALS

FLOORING

FLOORING ASSESSMENT

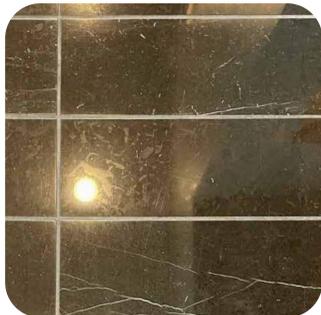
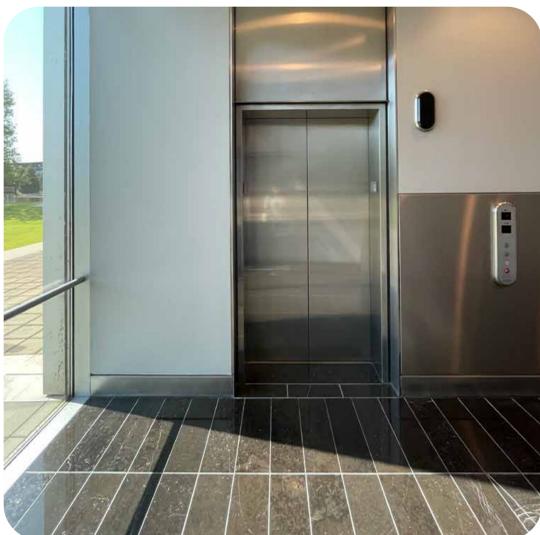
ST - 2
STONE FLOORING

DESCRIPTION
Marble Flooring

LOCATIONS
- Basement & Ground Floor Elevator Lobby
- Ground Floor Primary Lobby
- Ground Floor Travelling Exhibit Space - at entry and perimeter of room
- NARA Main Stair

CONDITION
- Fair
- Some scratches at Ground Level

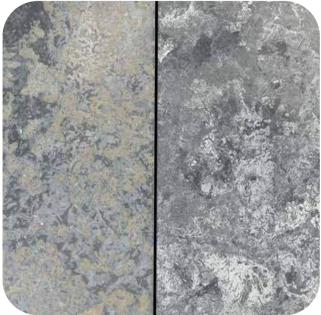
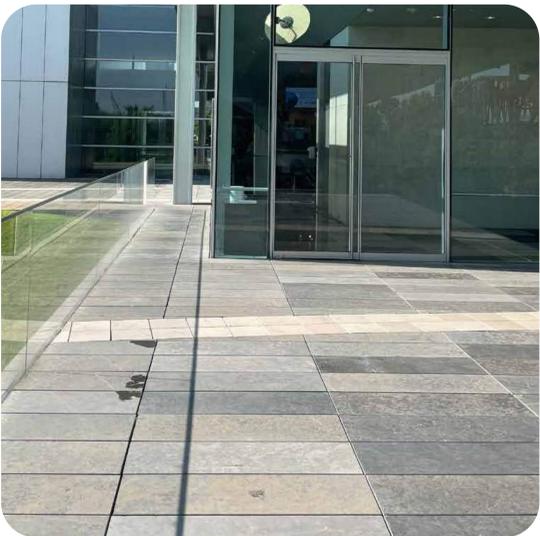
ST - 2E
EXTERIOR STONE FLOORING

24"x48"x1" stone paver on pedestal system

- Ground Floor Outdoor Terrace (north and south)

- Fair
- Some tiles missing

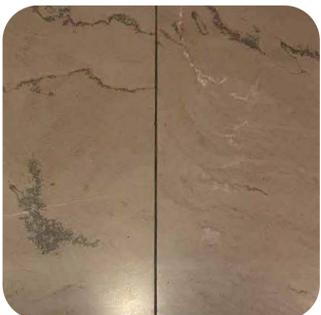
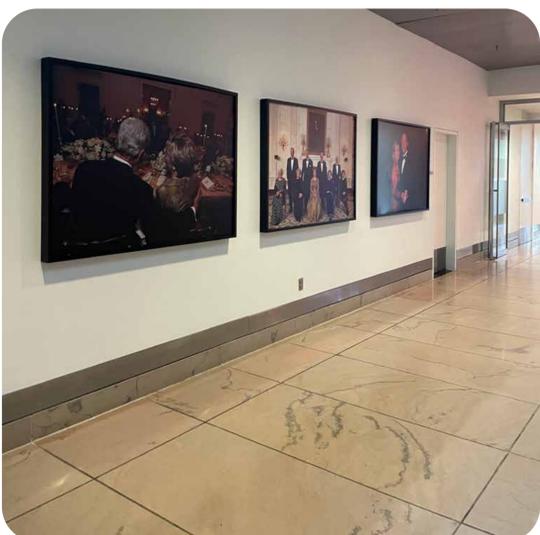
ST - 3
STONE FLOORING

24"x48"x1" stone paver over 2" topping slab in 3" structural slab recess

- Basement Lobby and Ground Floor Main Lobby band
- Cafe Perimeter
- Corridor to Cafe
- Lower Museum Level
- North Stair

Fair

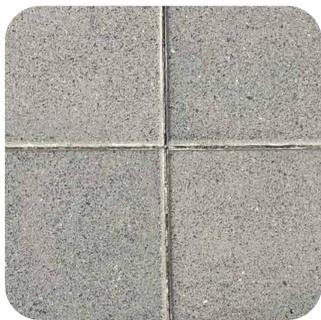
ST - 4
EXTERIOR CONCRETE PAVER

Precast Concrete Paver - Exterior use only

- Cafe Terrace Border
- Ground Floor Outdoor Terrace band (north and south)

Good

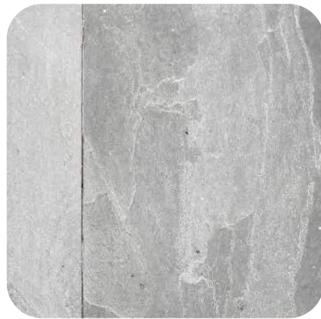
ST - 5
EXTERIOR STONE FLOORING

(Light) 24"x48"x1" Precast Concrete Paver on pedestal system - Exterior use only

- Cafe Terrace Border
- Ground Floor Outdoor Terrace band (north and south)

Good

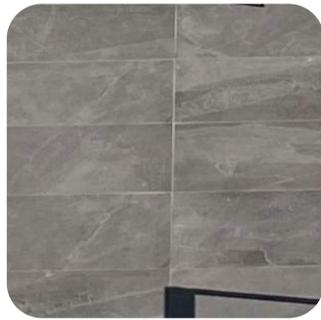
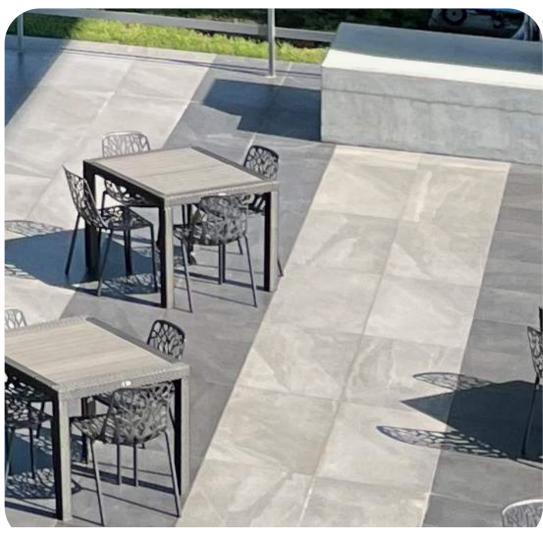
ST - 5A
EXTERIOR STONE FLOORING

(Dark) 24"x48"x1" Precast Concrete Paver on pedestal system - Exterior use only

- Cafe Terrace Border
- Ground Floor Outdoor Terrace band (north and south)

Good

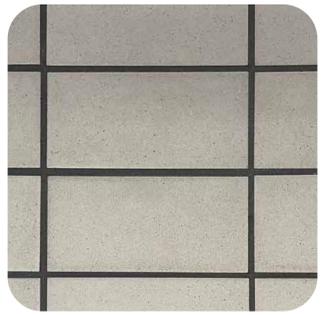
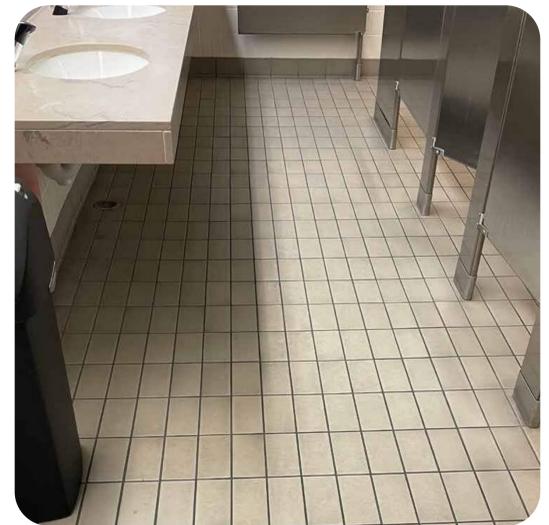
CT - 1
TILE FLOORING

DESCRIPTION
Ceramic Tile

LOCATIONS
- Basement public re-
strooms
- Ground public re-
strooms
- Museum public re-
strooms

CONDITION
Fair
clean grout

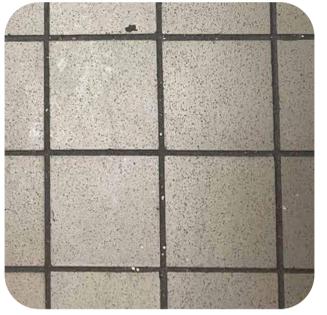
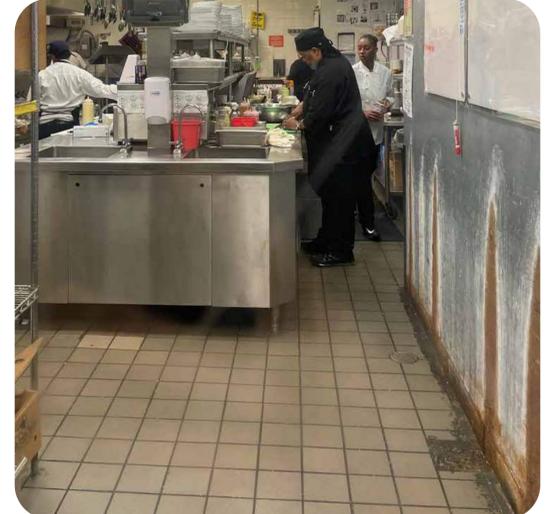
QT - 1
TILE FLOORING

DESCRIPTION
Quarry tile on
topping slab
Base type varies

LOCATIONS
- Cafe Kitchen

CONDITION
Poor
Clean grout

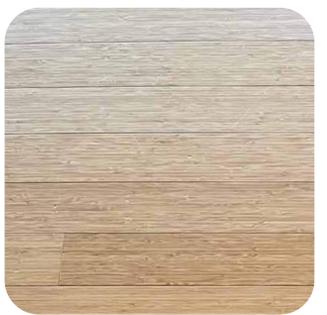
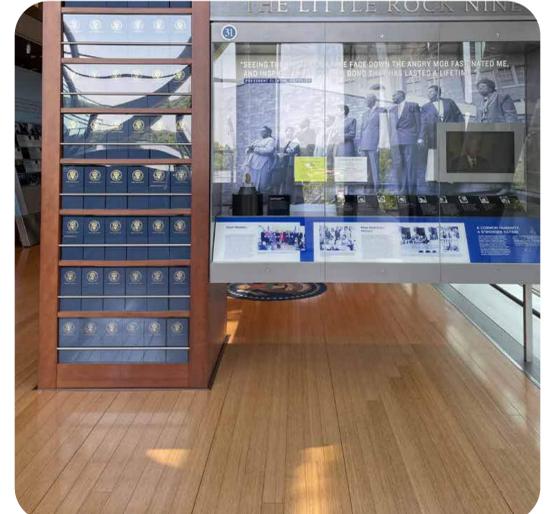
WDF - 1
WOOD FLOORING

DESCRIPTION
Bamboo Wood
Flooring

LOCATIONS
- NARA Permanent
Exhibits
- NARA Temporary
Exhibits
- SKy Lobby
- Great Hall

CONDITION
- Fair
- Some scratches,
dents, marks

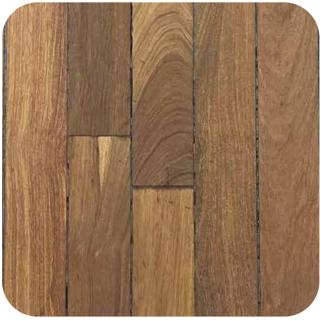
WDF - 2
WOOD FLOORING

- Cafe dining area
- beverage station in kitchen

- Water damage at bev. station

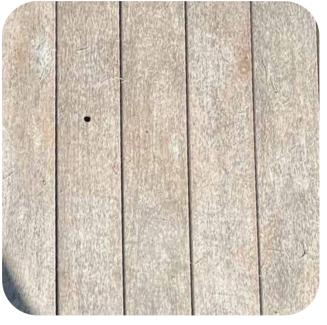
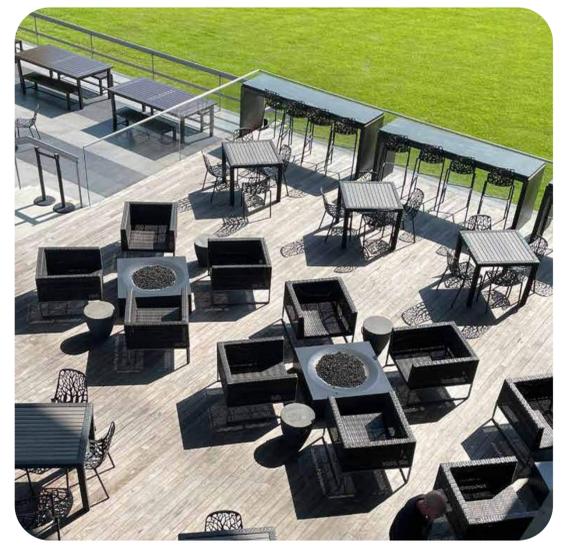
WDF - 3
WOOD DECK

- Wood Deck (Exterior)

- Cafe Terrace

- Good

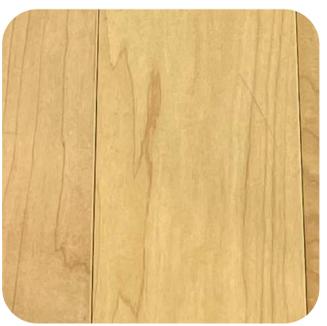
WDF - 4
WOOD FLOORING

- Executive Level Kitchen, Living room, Library

- Good

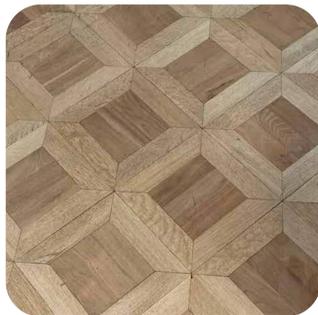
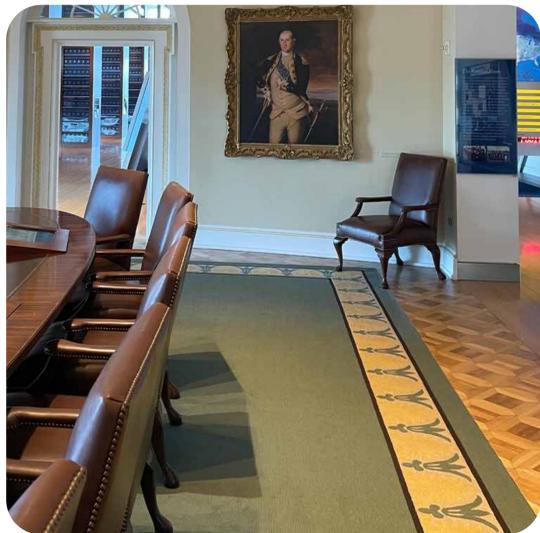
WDF - 5
WOOD FLOORING

Parquet Wood
Flooring

- Cabinet Room
(around carpet)

- fair
- deep scratches
- some damage at
edge transitions

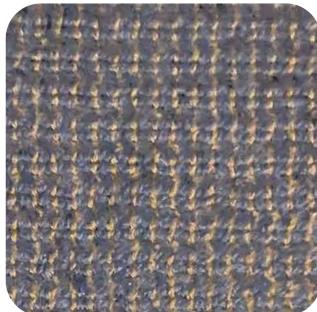
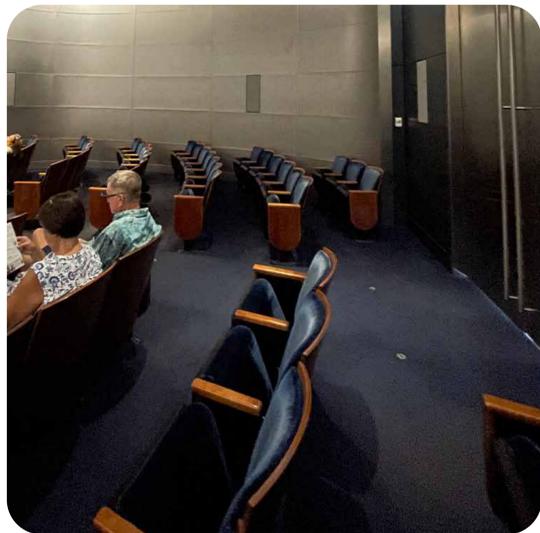
CPT - 2
CARPET

- Orientation Theater

- Good

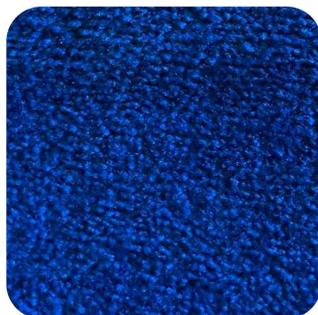
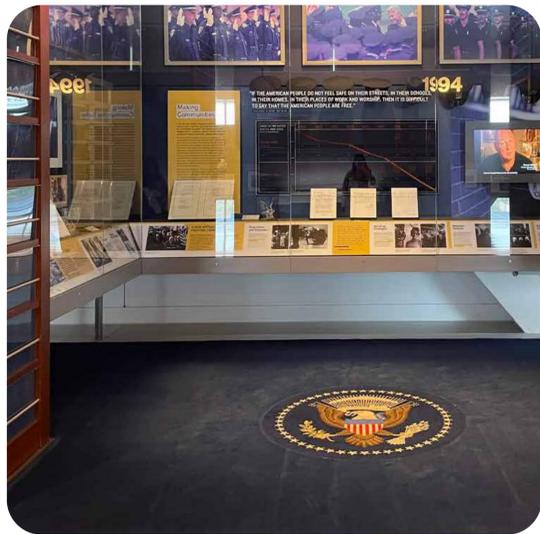
CPT - 3
CARPET

- NARA Permanent
Exhibit
- Green Rm
- Cabinet Rm

- Good

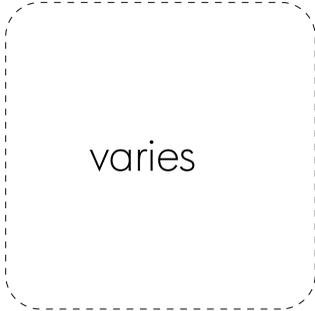
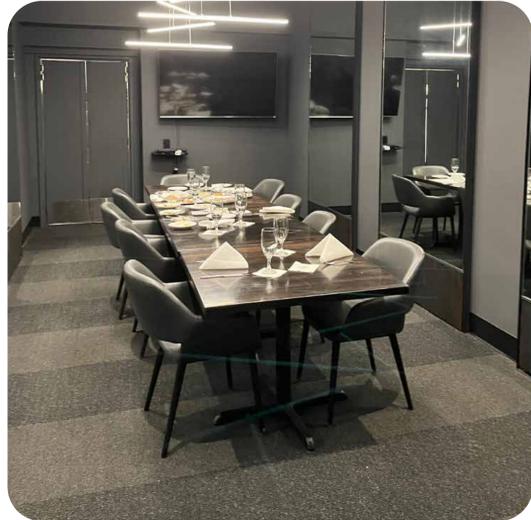
CPT - X
CARPET

- unknown

- Private Dining Rm (Basement Level)
- Lobby Event Space (Ground Floor)
- NARA Offices, Volunteer Lounge and Coordination
- Secret Service RM

- Good

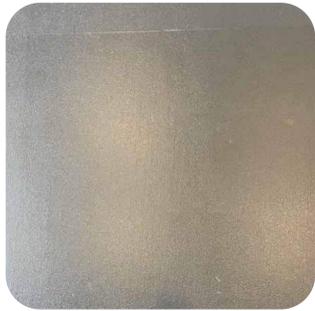
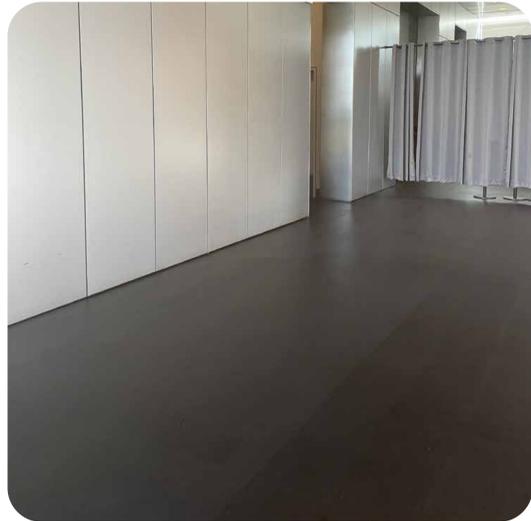
RF - 1
RESILIENT FLOOR

- Core Lobby at Basement, Ground Level, Lower Museum Level, Upper Museum Level
- Freight Elevator Lobby

- Fair
- Some scratches

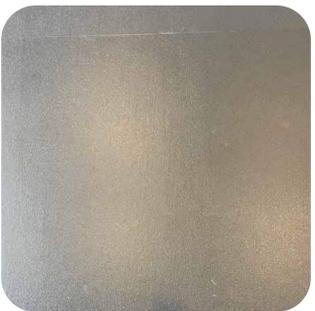
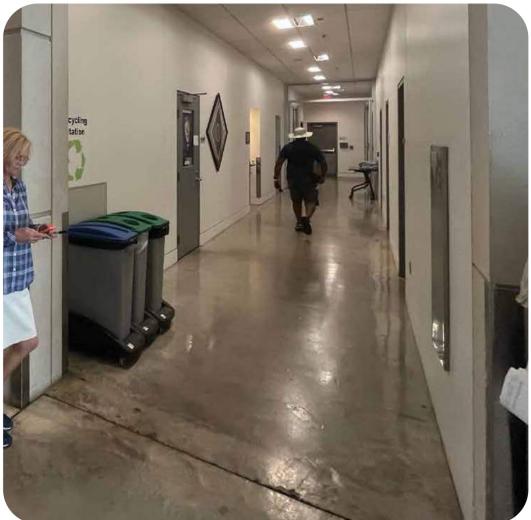
SC - 1
SEALED CONCRETE

- NARA Corridors

- Good

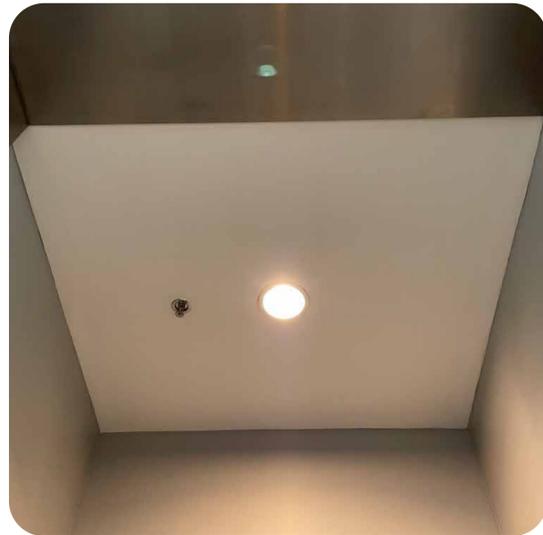
GWB

DESCRIPTION
Gypsum Wall Board with paint
(Premium where noted)

LOCATIONS
-Cafe Corridor, Cafe perimeter, Cafe Kitchen (band)
-Elevator Lobby in Basement, Ground Level,
-Women, Men, Lavatory Vestibule in Basement, Ground Level,
-Coat Room
-NARA Corridor
-Cabinet Room

CONDITION
-Fair
-Consider re-paint

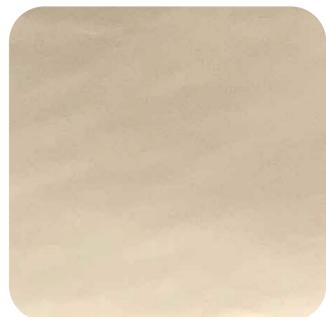
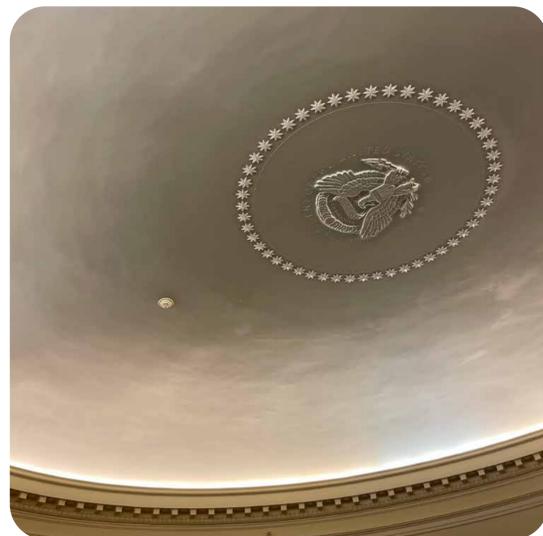
PLASTER FINISH

DESCRIPTION
Plaster Finish

LOCATIONS
-Oval Office

CONDITION
Good

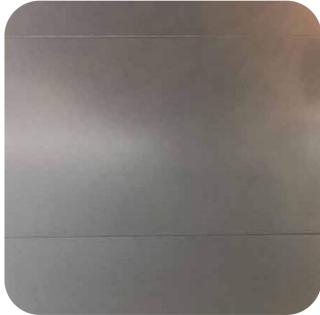
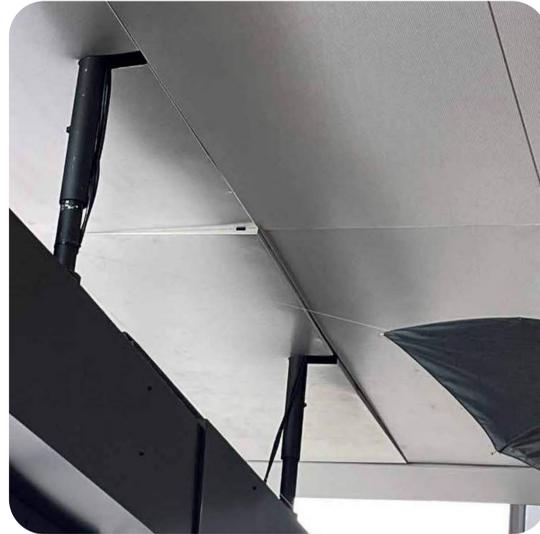
ACP - 1

Aluminum Ceiling Panel (perforated)

- Ground Level Security
- Ground Level Main Lobby
- Lobby Event Space (Ground Level)

- Good
- Some panels not flush

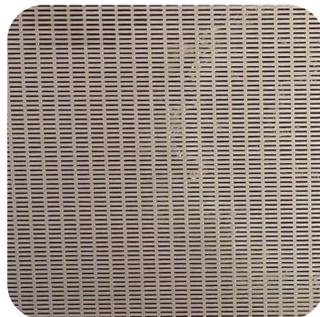
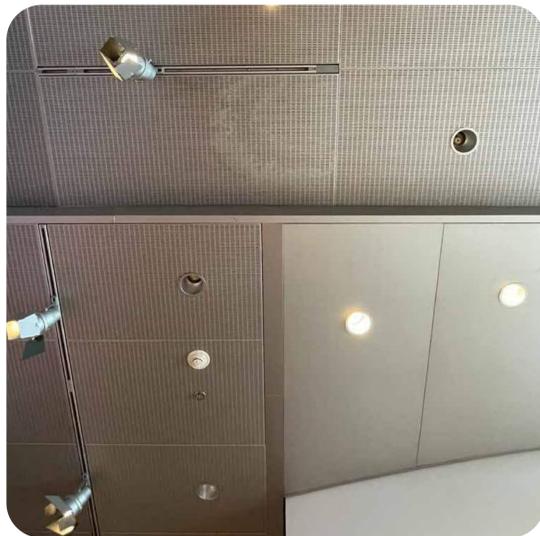
ACP - 2

Perforated Aluminum Ceiling Panel

- NARA Permanent Exhibits
- Sky Lobby at Lower Museum Level
- Lower Museum Level Lavatory (3-08)

- Good
- Some signs of water

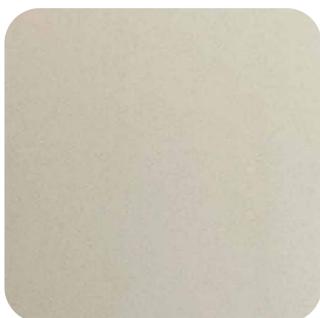
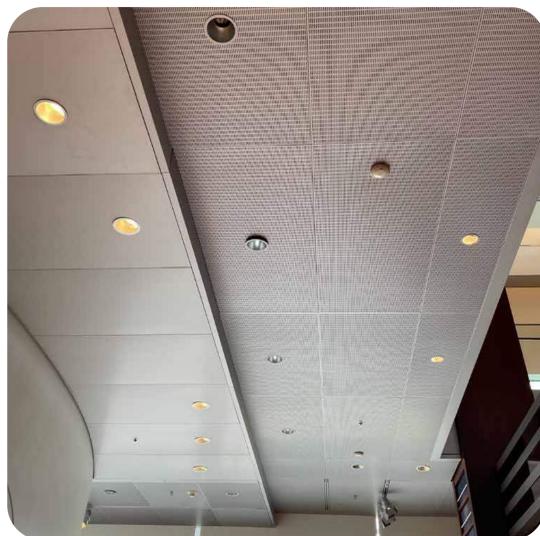
ACP - 2A

Aluminum Ceiling Panel

- Cafe Interior
- NARA Permanent Exhibits, North of Cabinet Room in Lower Museum level

Good

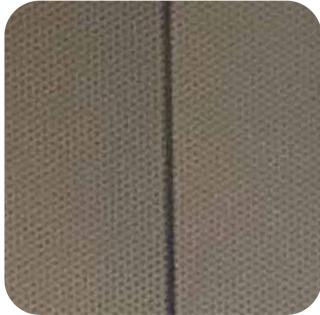
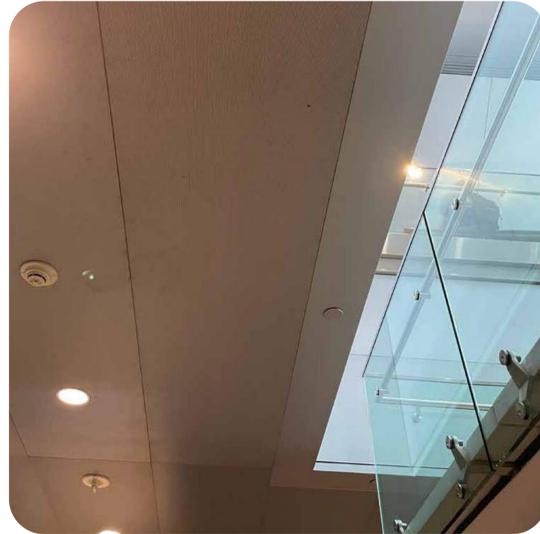
ACP - 2B

Perforated Aluminum Ceiling Panel

- B-01 Basement Lobby

- Good
- Some signs of water

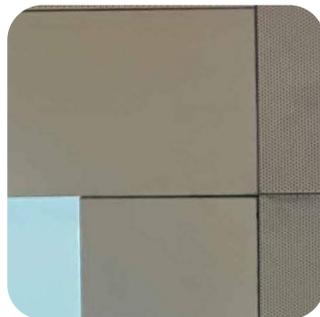
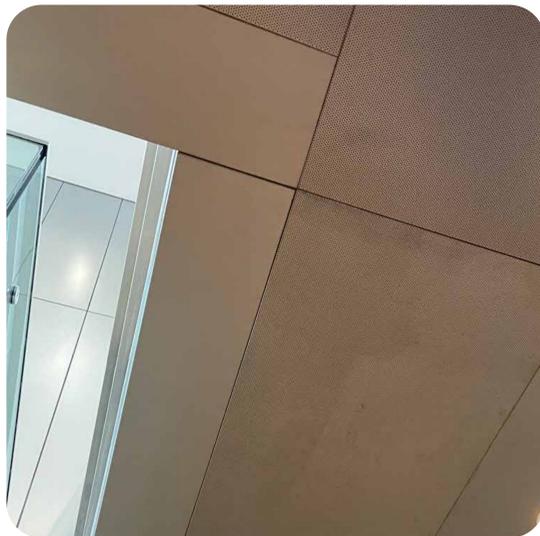
ACP - 2C

Aluminum Ceiling Panel

- B-01 Basement Lobby (Perimeter of stairs)
- Escalator Landing

- Good

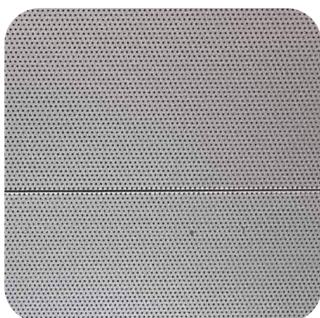
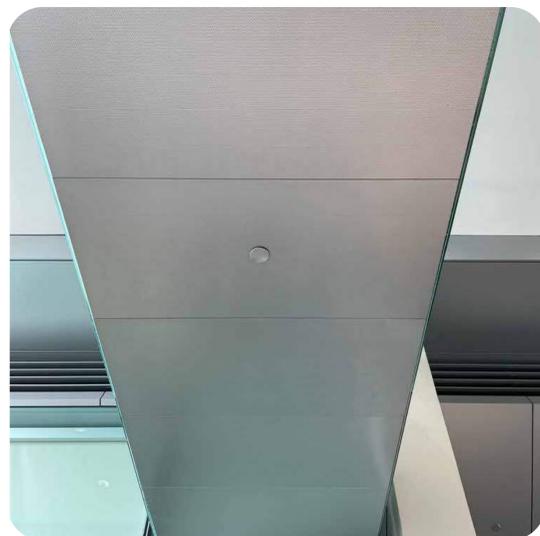
ACP - 2D

Perforated Aluminum Ceiling Panel

- 1-01 Main Lobby & Gift Shop
- B-01 Basement Lobby
- Bridge at Core Lobby in Ground Level

Good

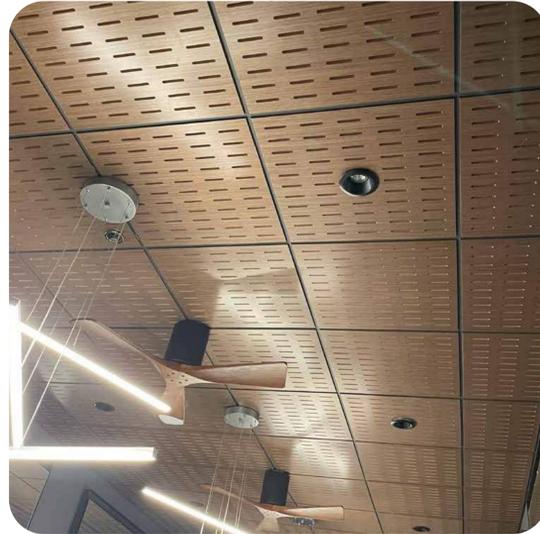
ACT - WD

2x2 Perforated Wood Acoustical Ceiling Panel

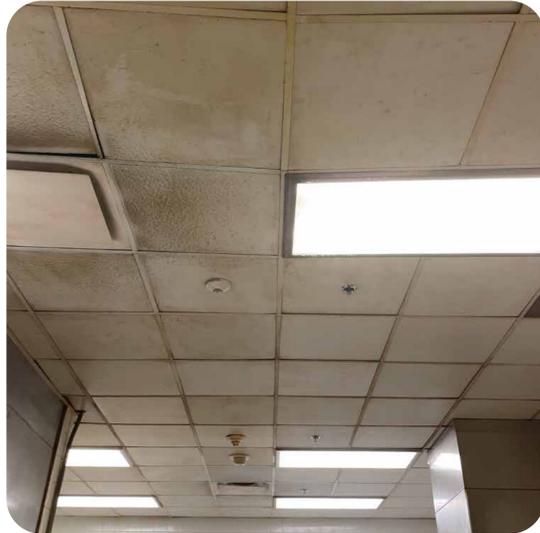
ACT - 1

2x2 Acoustical Ceiling Tile (Wet Space)

- Cafe Kitchen

- Poor

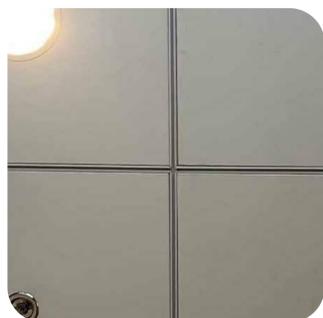
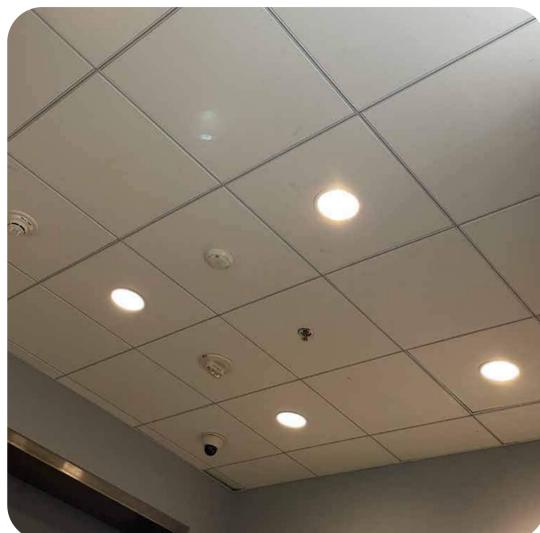
ACT - 2

2x2 Acoustical Ceiling Tile

- Freight Elev. Vestibule (Basement & Ground Level)
- NARA Classrooms,
- NARA Offices, Volunteer Lounge, Coordination Room

Good

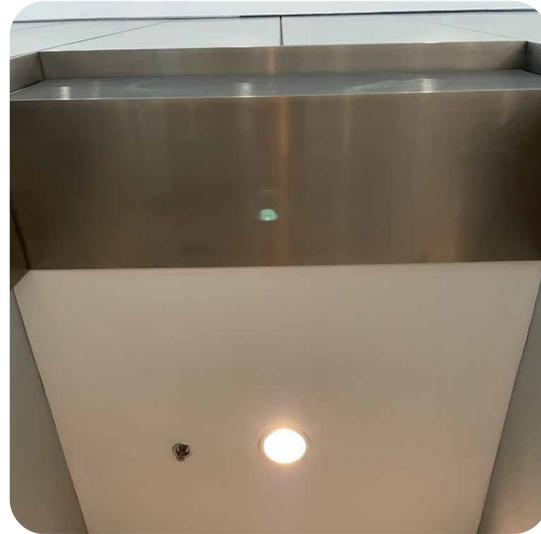
SS-1

Stainless Steel Finish
(Plate where noted)

- Basement and Ground Level Elevator Lobby
- Basement and Ground Level Lavatory Vestibule threshold
- South entry to Orientation Theater

- Good

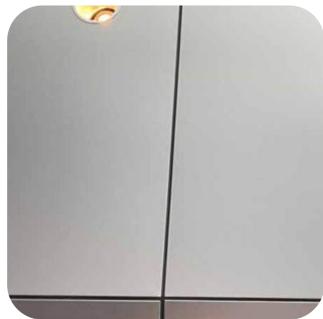
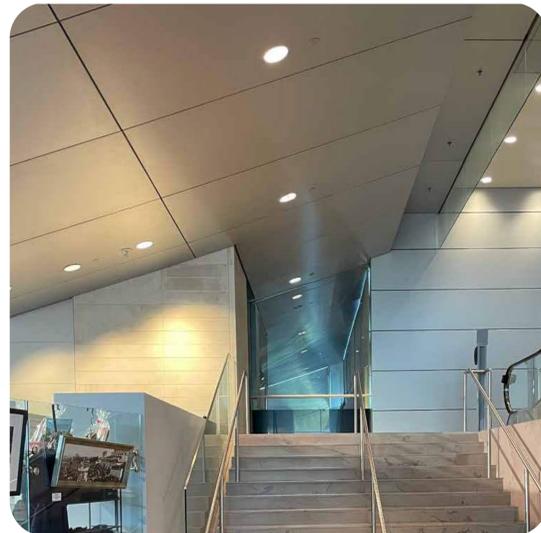
ACM - 1

Stainless Steel Finish
(Plate where noted)

- Basement and Ground Level Elevator Lobby
- Basement and Ground Level Lavatory Vestibule threshold
- South entry to Orientation Theater

- Good

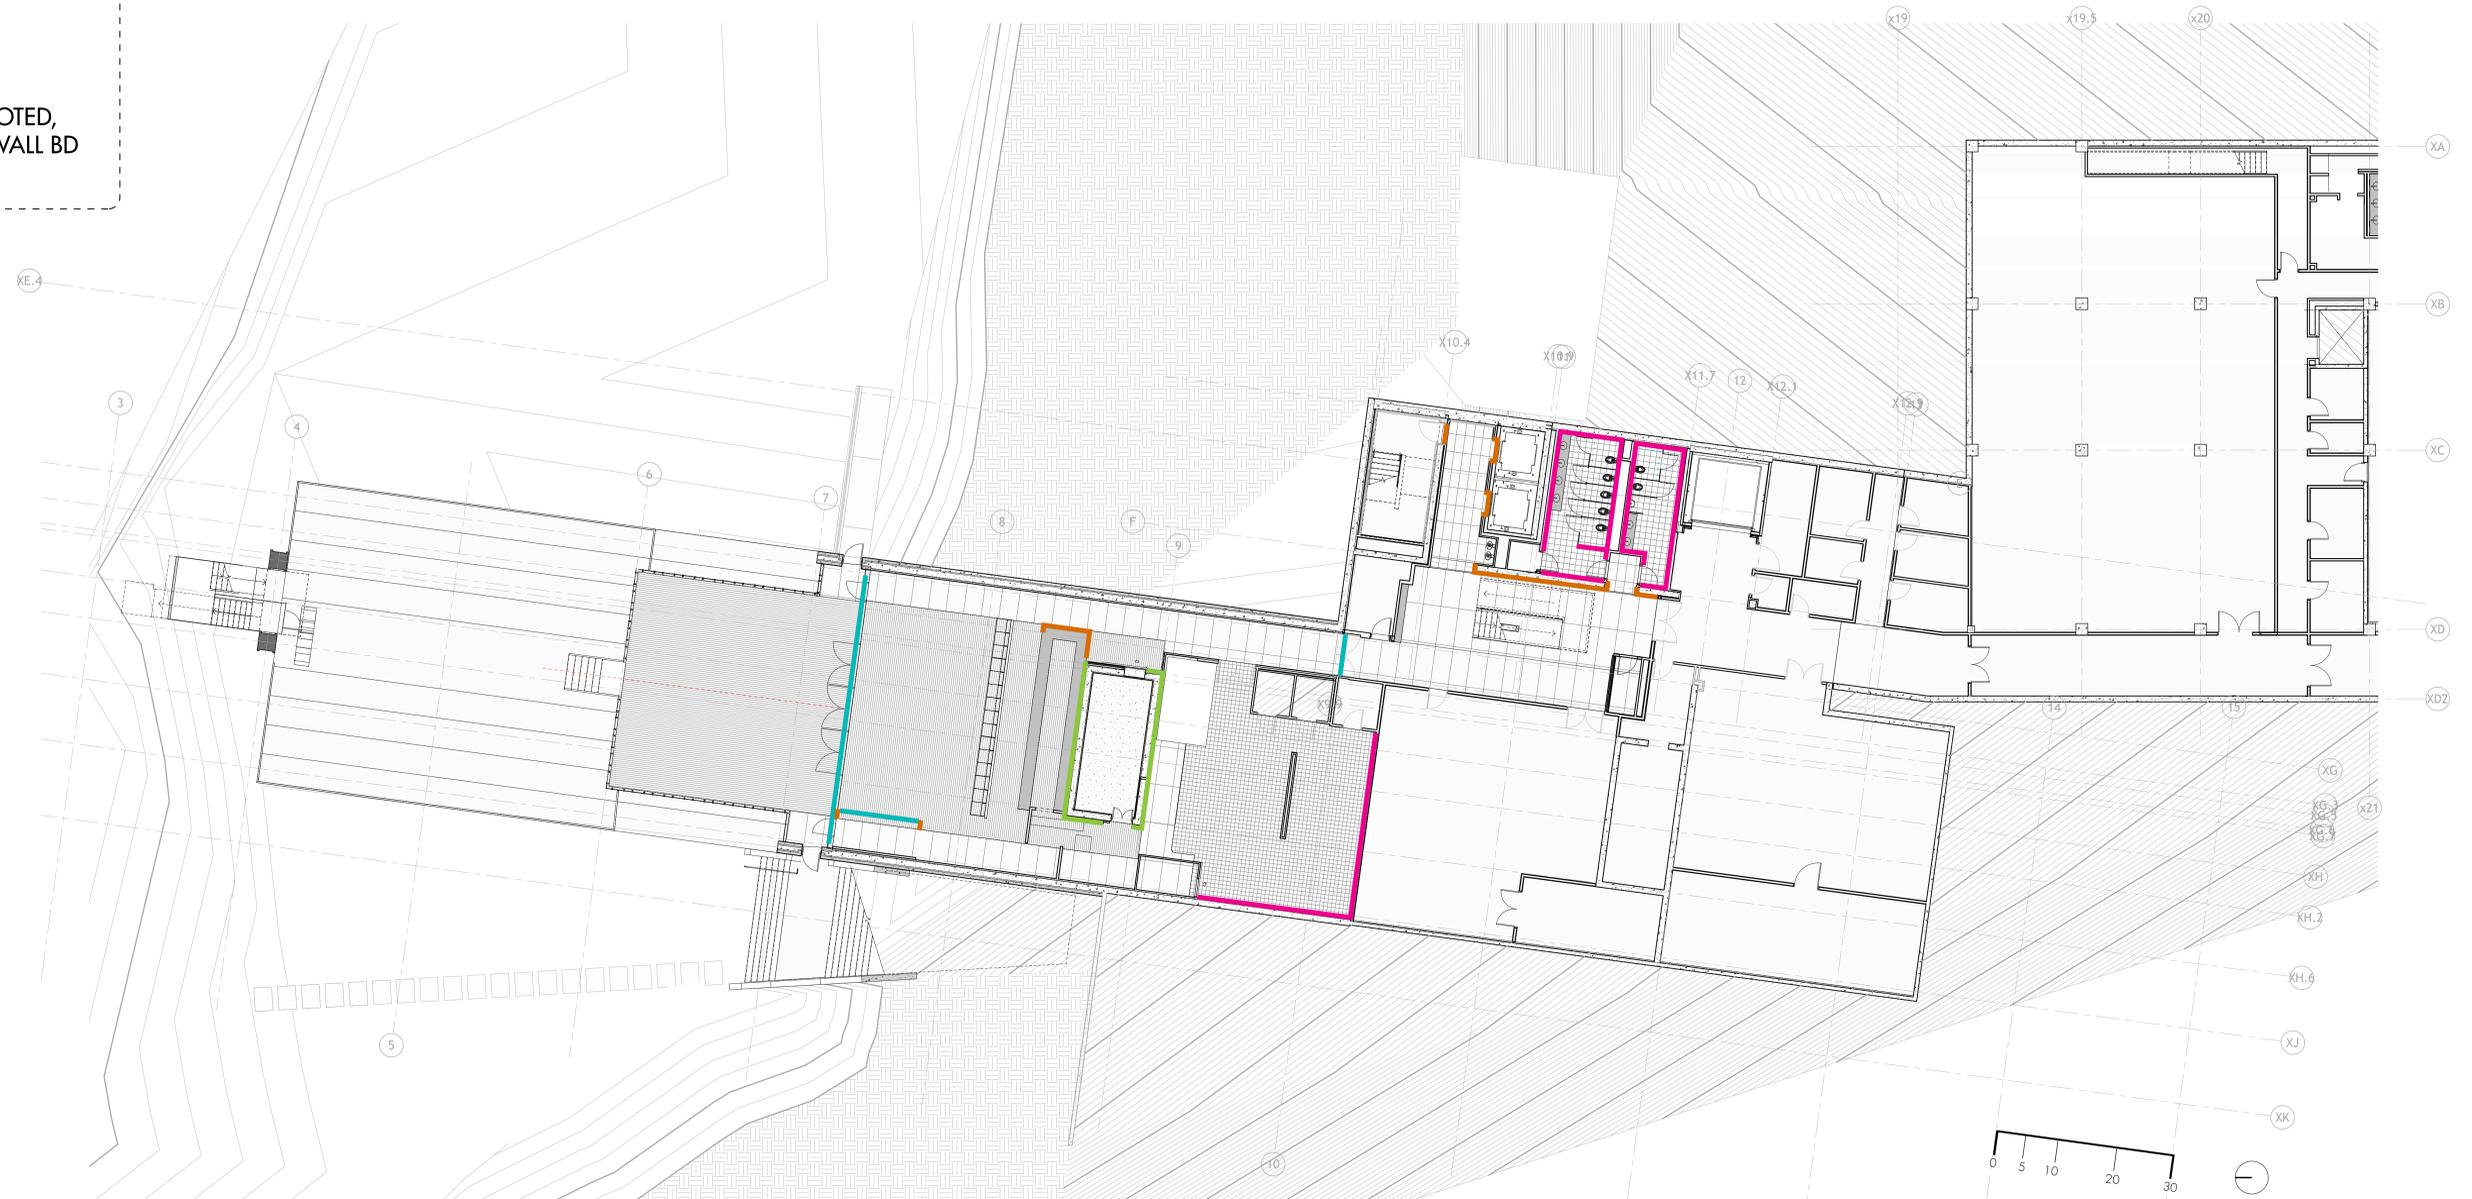
BASEMENT LEVEL

WALL MATERIAL DIAGRAM

UNLESS NOTED, GYPSUM WALL BD

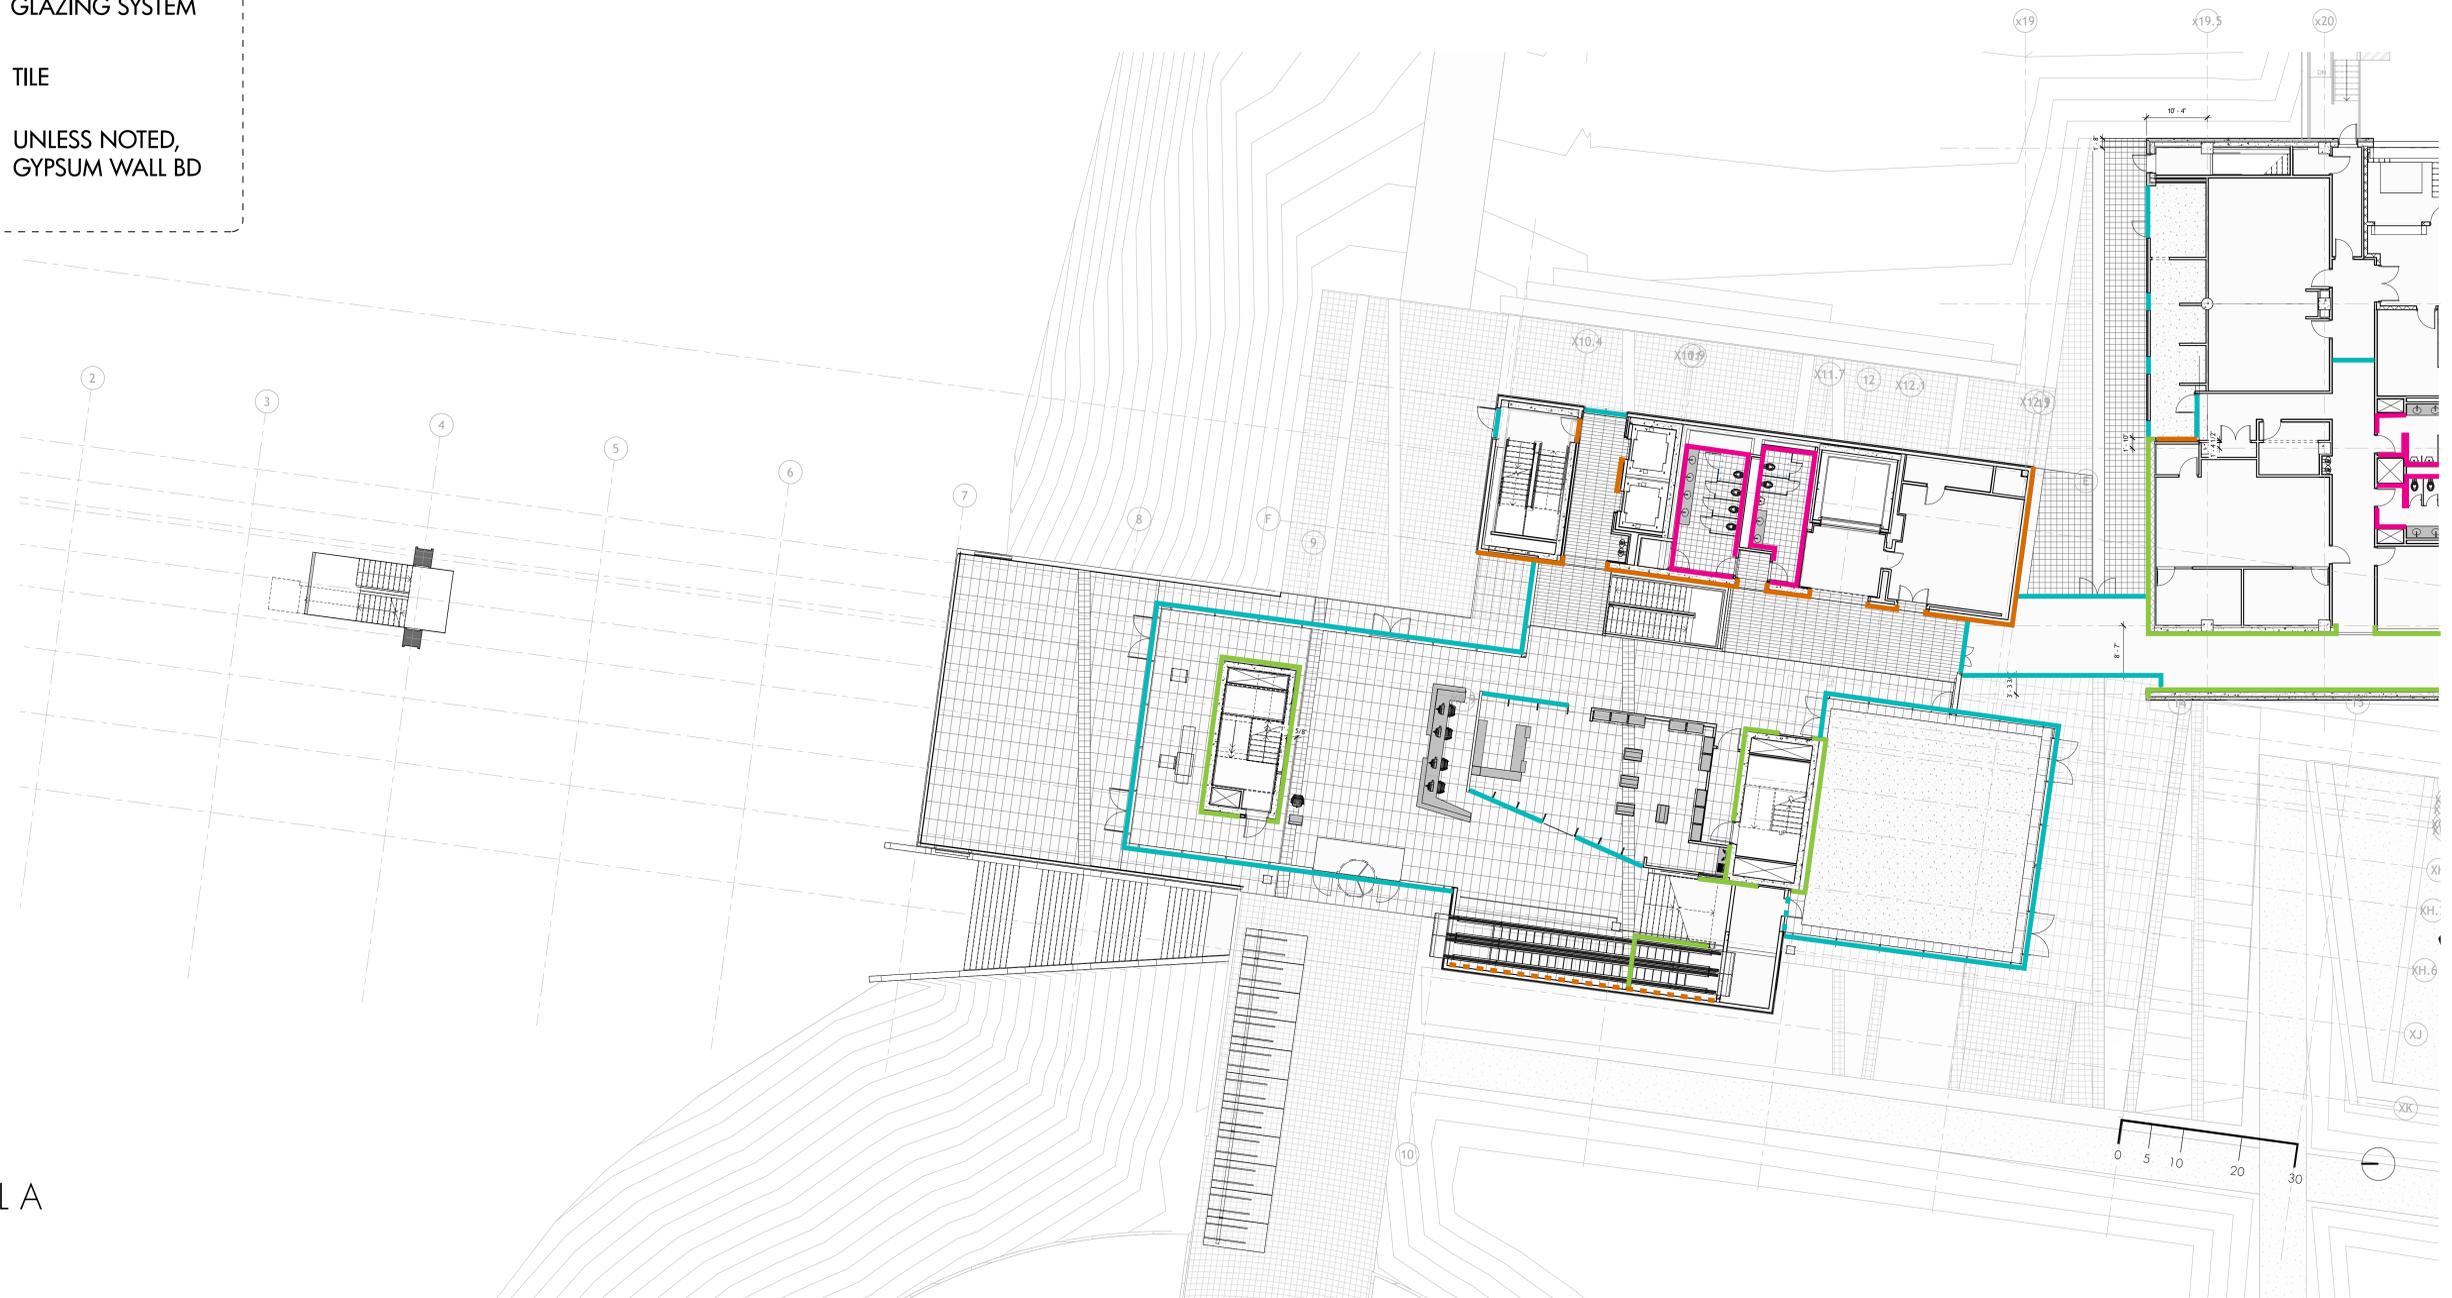
GROUND LEVEL A

WALL MATERIAL DIAGRAM

UNLESS NOTED, GYPSUM WALL BD

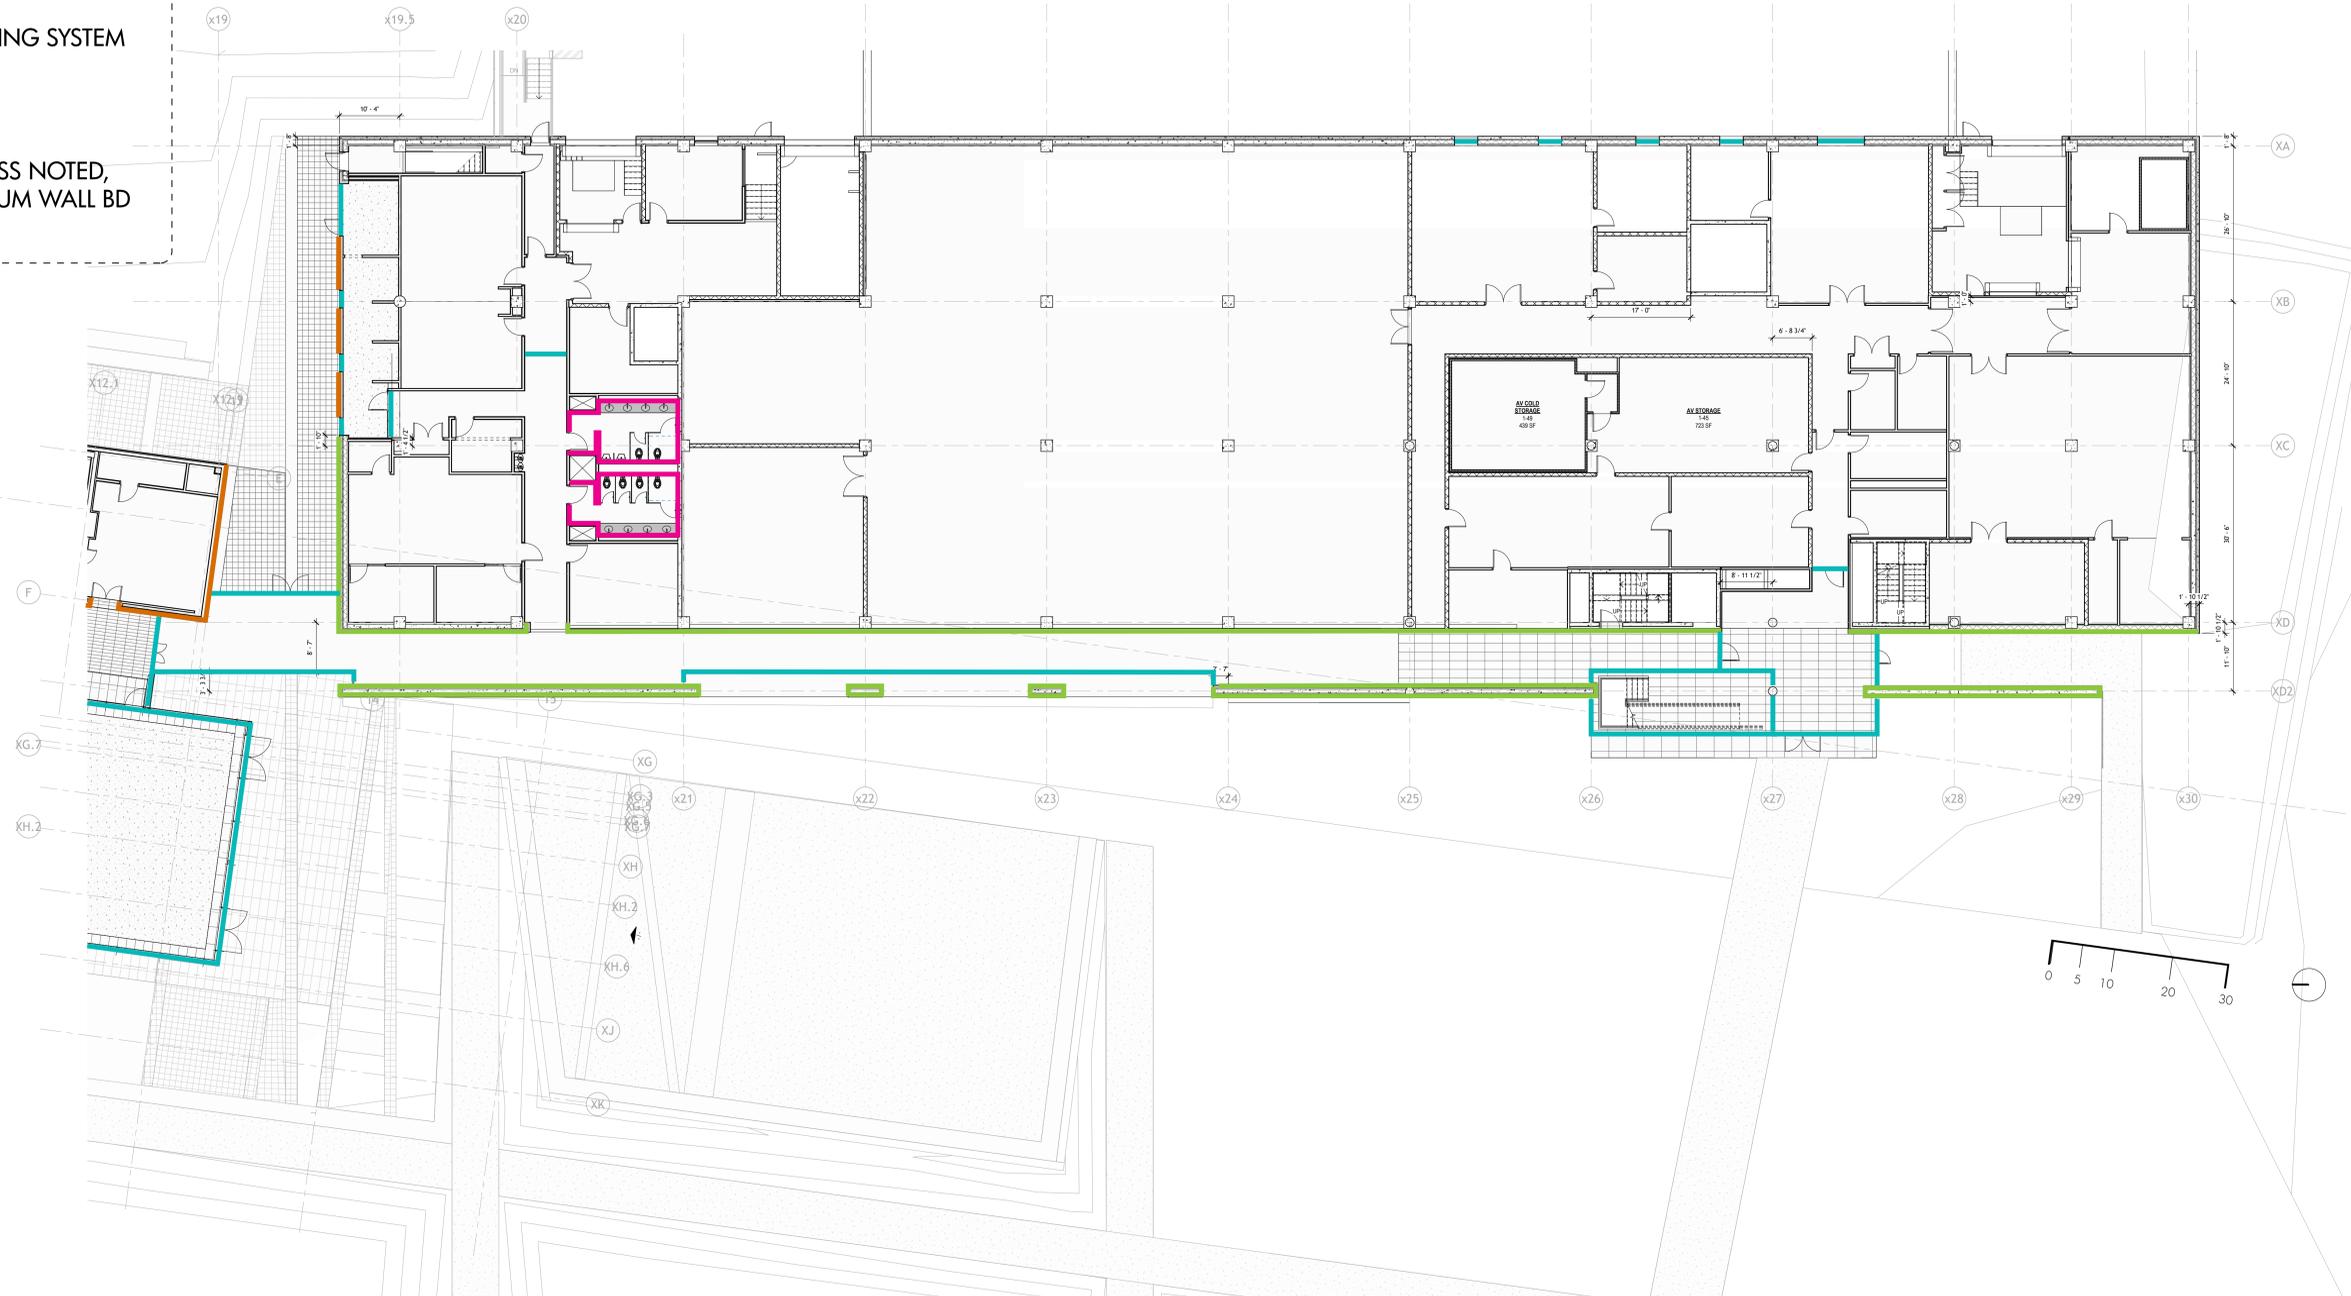
GROUND LEVEL B

WALL MATERIAL DIAGRAM

UNLESS NOTED, GYPSUM WALL BD
