ARCHITECTURAL FINISHES & MATERIALS

FLOORING

FLOORING ASSESSMENT

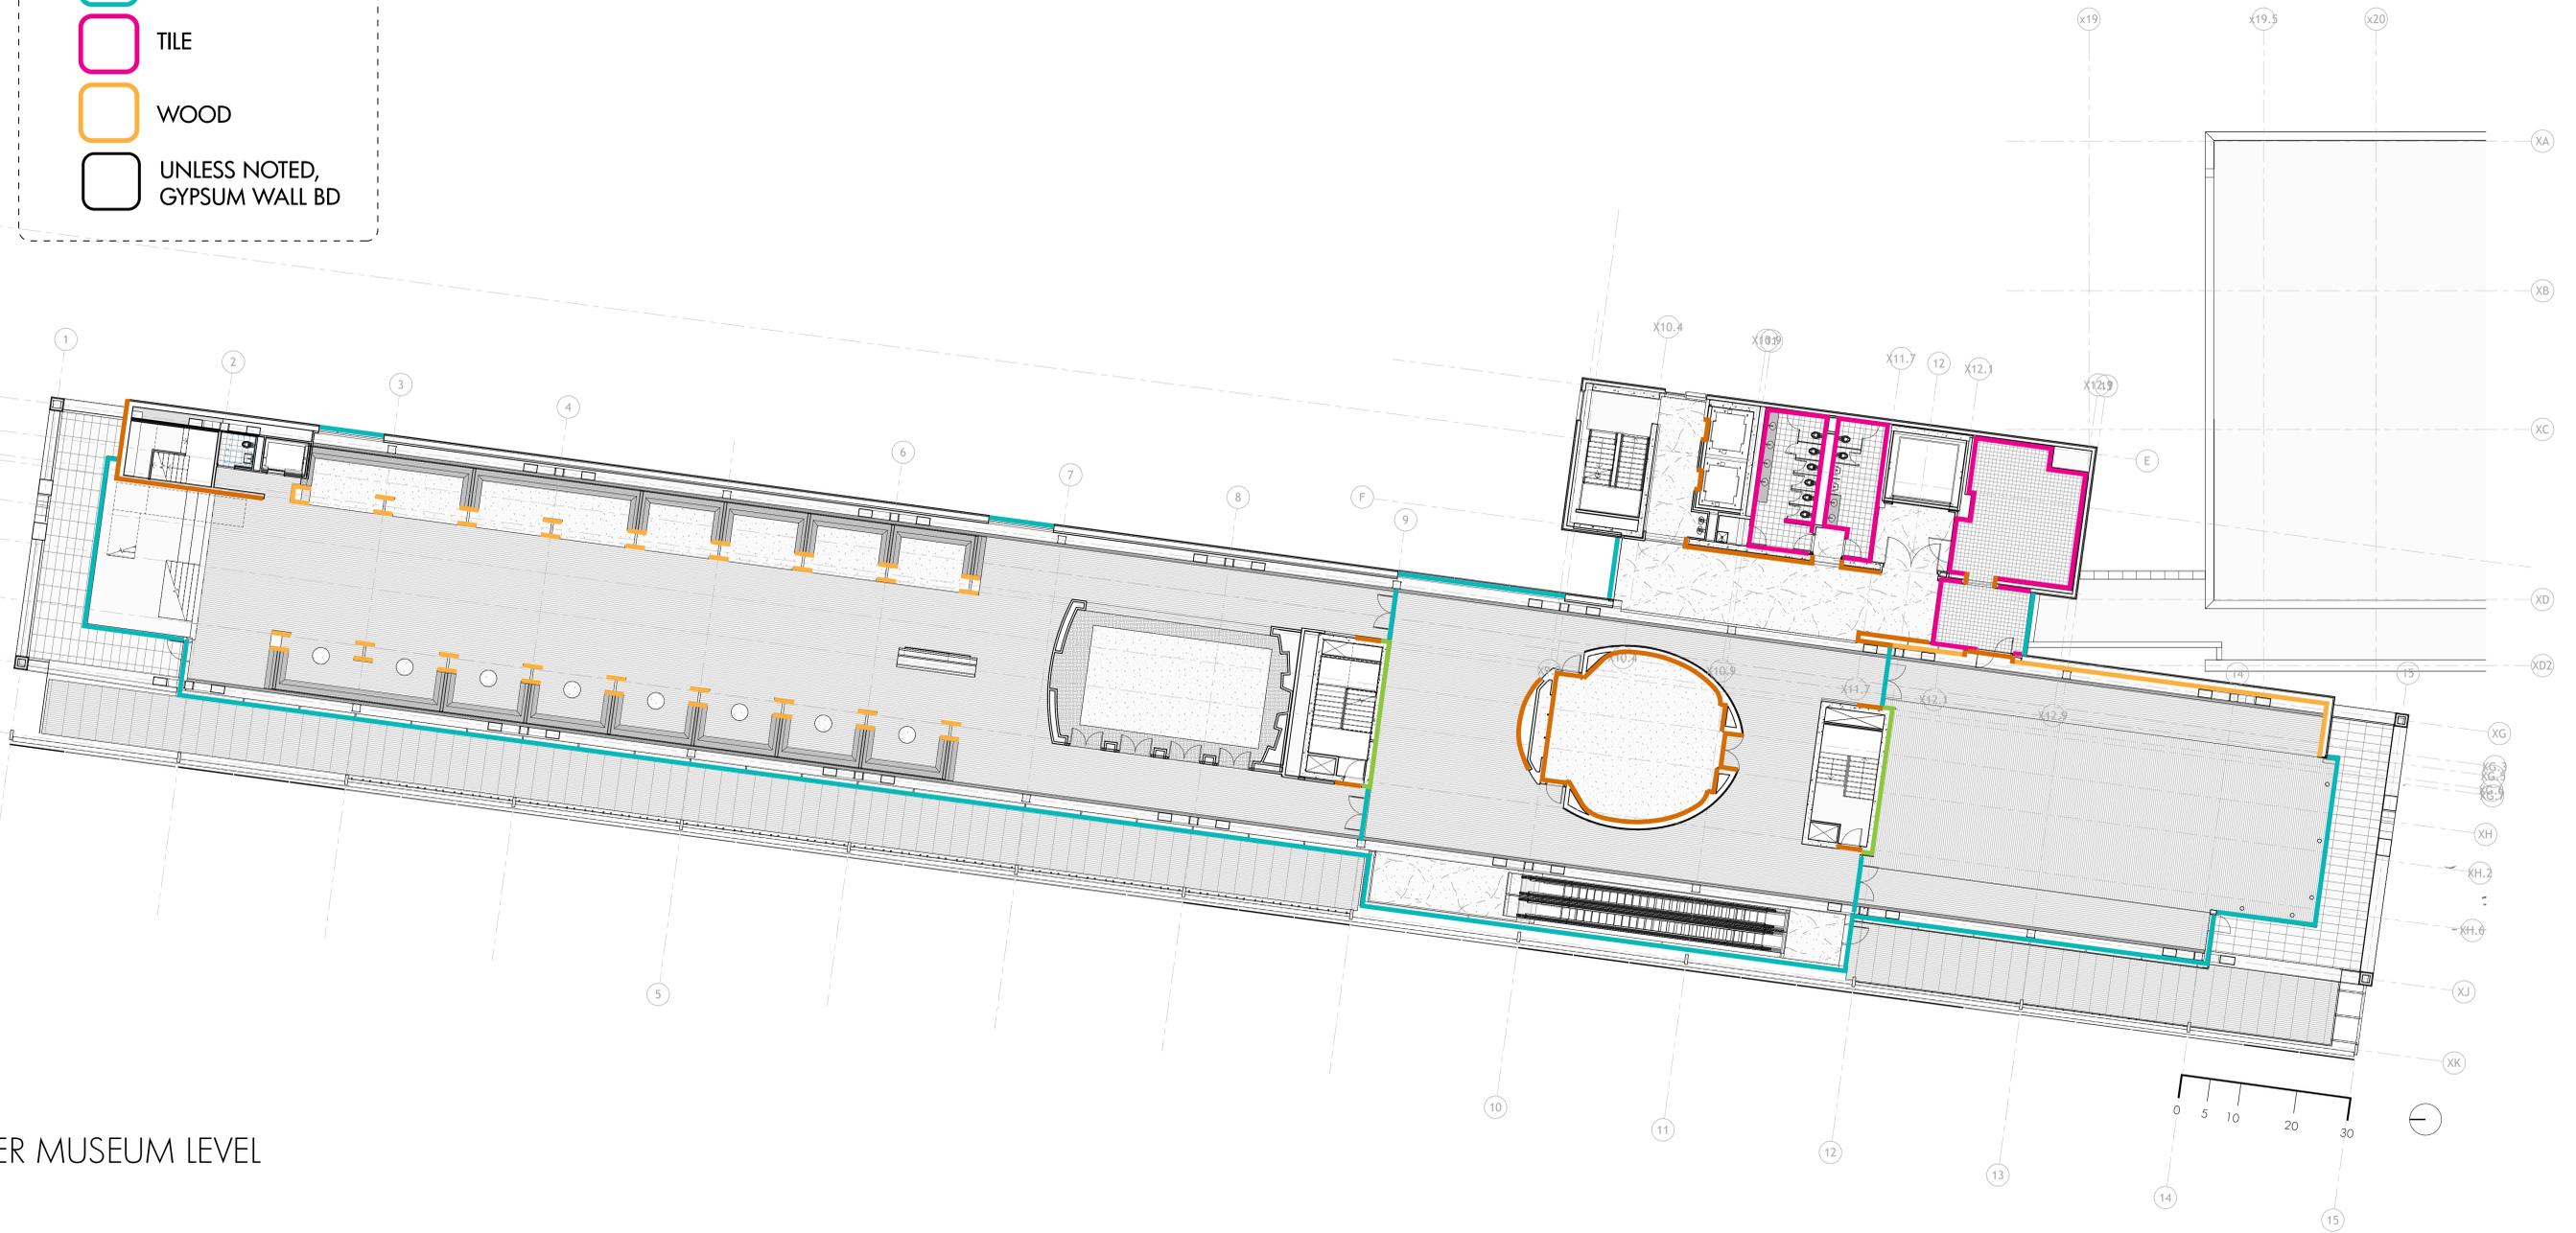
LOWER MUSEUM LEVEL

WALL MATERIAL DIAGRAM

- STONE
- METAL PANEL
- GLAZING SYSTEM
- TILE
- WOOD
- UNLESS NOTED,
GYPSUM WALL BD

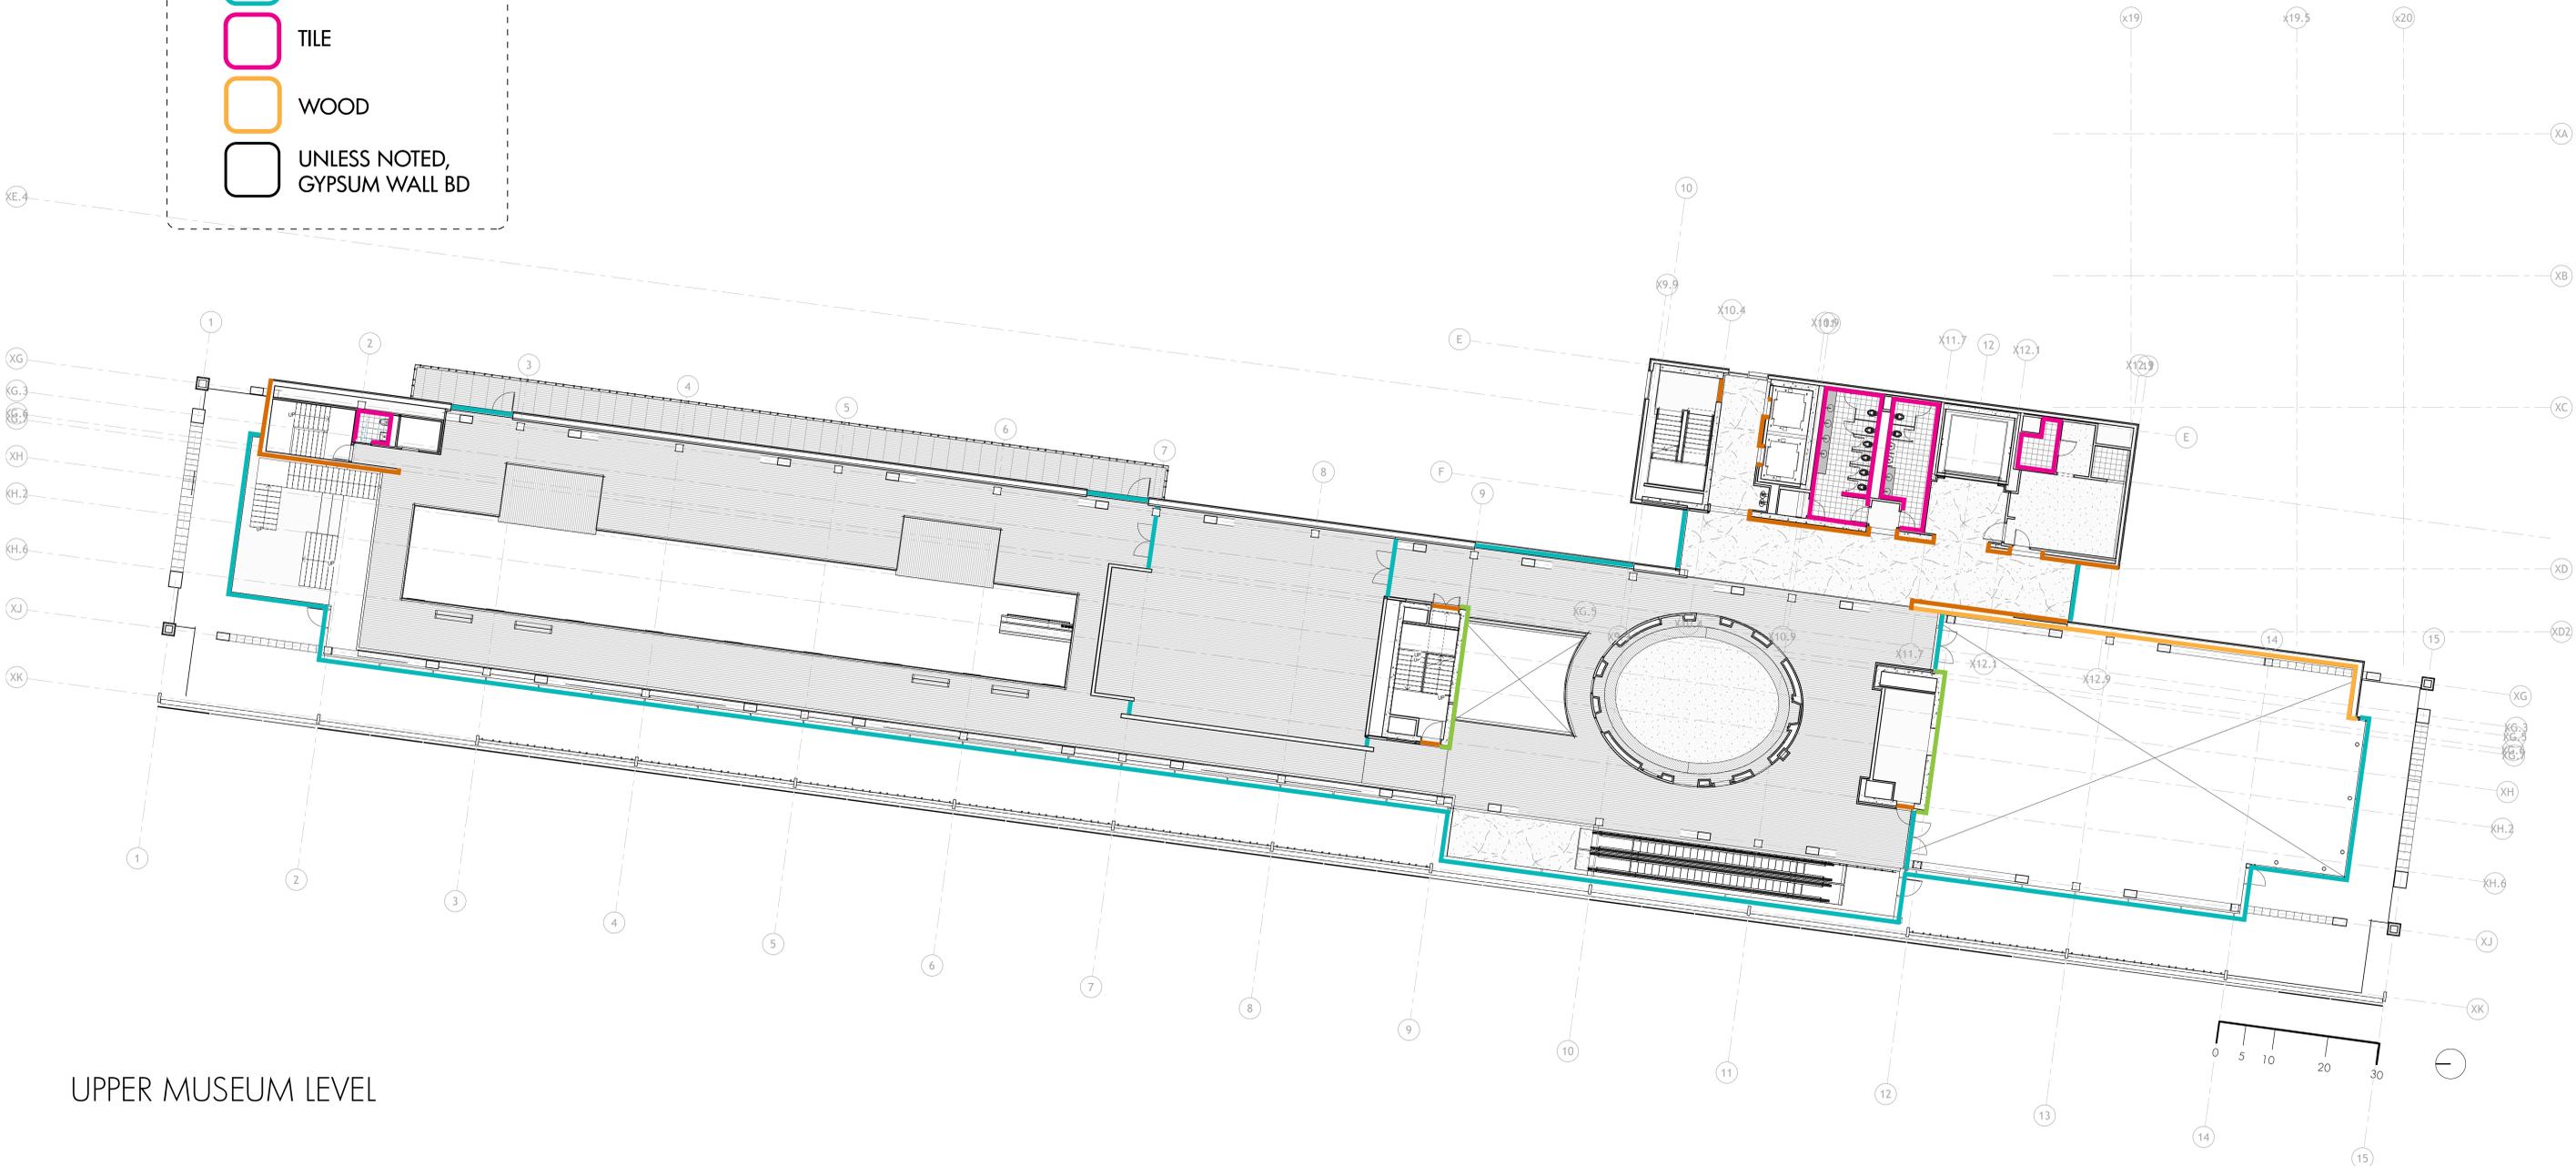
UPPER MUSEUM LEVEL

WALL MATERIAL DIAGRAM

- STONE
- METAL PANEL
- GLAZING SYSTEM
- TILE
- WOOD
- UNLESS NOTED, GYPSUM WALL BD
