1 Demolition Roof Plan
 AX1.4 1/8" = 1'-0" SCALE (A)

SUB SHEET NO.
01
AX1.4

DRAWING NO.
128
182951
 PMIS/PKG NO.
 318915
 SHEET
 31 OF 286

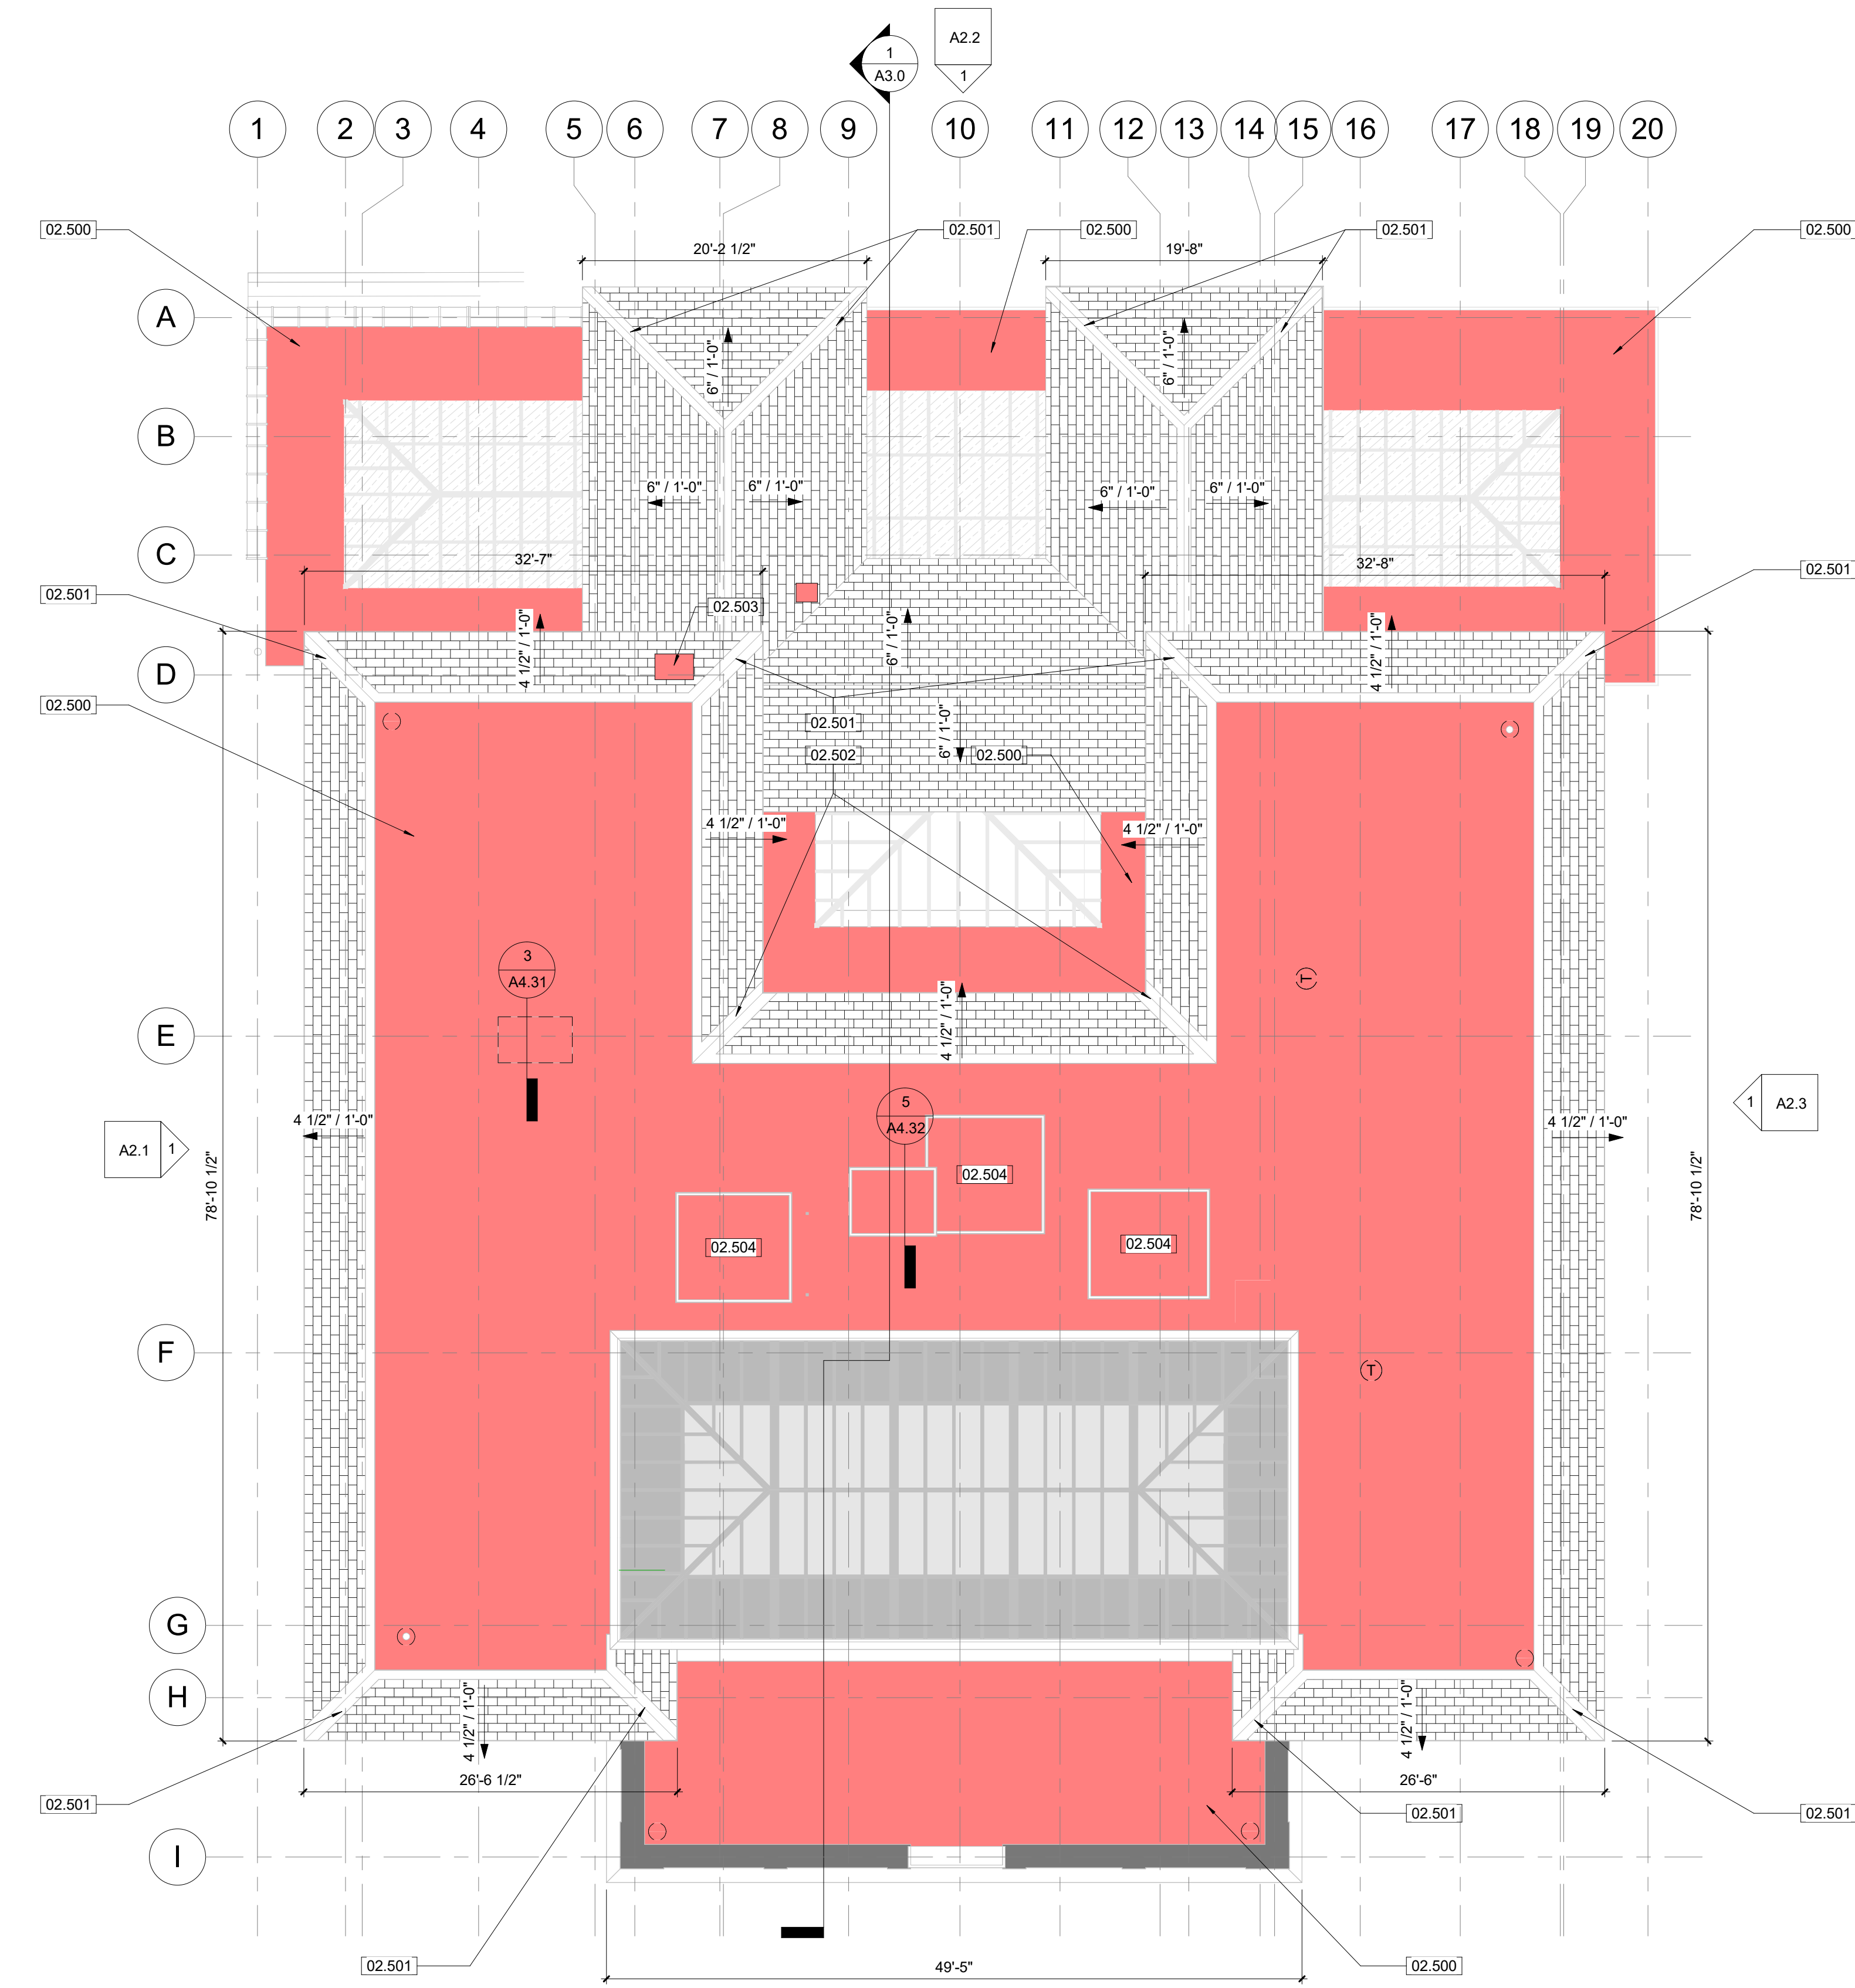
02.500	024296 - REMOVE MEMBRANE ROOFING, INSULATION, AND ASSOCIATED FLASHING AT LOW SLOPE ROOF SURROUNDING TRANSLUCENT PANEL SKYLIGHTS, OVER SUN PORCH, AND AT THE MAIN ROOF.
02.501	024296 - REMOVE AND SALVAGE CLAY RIDGE CAP TILES, REMOVE CORRODED METAL FLASHING. (+/-135 LF)
02.502	024296 - REMOVE AND SALVAGE CLAY ROOFING TILES AT VALLEYS, REMOVE CORRODED METAL VALLEY FLASHING (+/-72 LF FLASHING)
02.503	024296 - REMOVE AND SALVAGE CLAY TILES IN LOCATION THAT CLAY TILE SLIPPED AND REVEALED DETERIORATED WOOD SHEATHING BELOW (3 SF).
02.504	024296 - REMOVE MEMBRANE ROOFING, INSULATION, AND ASSOCIATED FLASHING AT ROOF TOWERS.
