**1** North Elevation  
**A2.1** 1/8" = 1'-0" SCALE (A)

<b>A/E FIRMS</b> PRIME/ARCH: STRATA ARCHITECTURE 1701 OAK STREET, SUITE 100 KANSAS CITY, MO T: 816.474.0900	DESIGNED: CA/AG	SUB SHEET NO.  <b>01</b> <b>A2.1</b>	TITLE OF SHEET <b>MAURICE BATHHOUSE</b> <b>NORTH ELEVATION</b>  REHABILITATE BATHHOUSES HOT SPRINGS NATIONAL PARK	DRAWING NO. <b>128</b> <b>182951</b>
	CADD: CA/ZA/EM			PMIS/PKG NO. 318915
	TECH. REVIEW: AG			SHEET 54 OF 286
	DATE: 10.27.2023

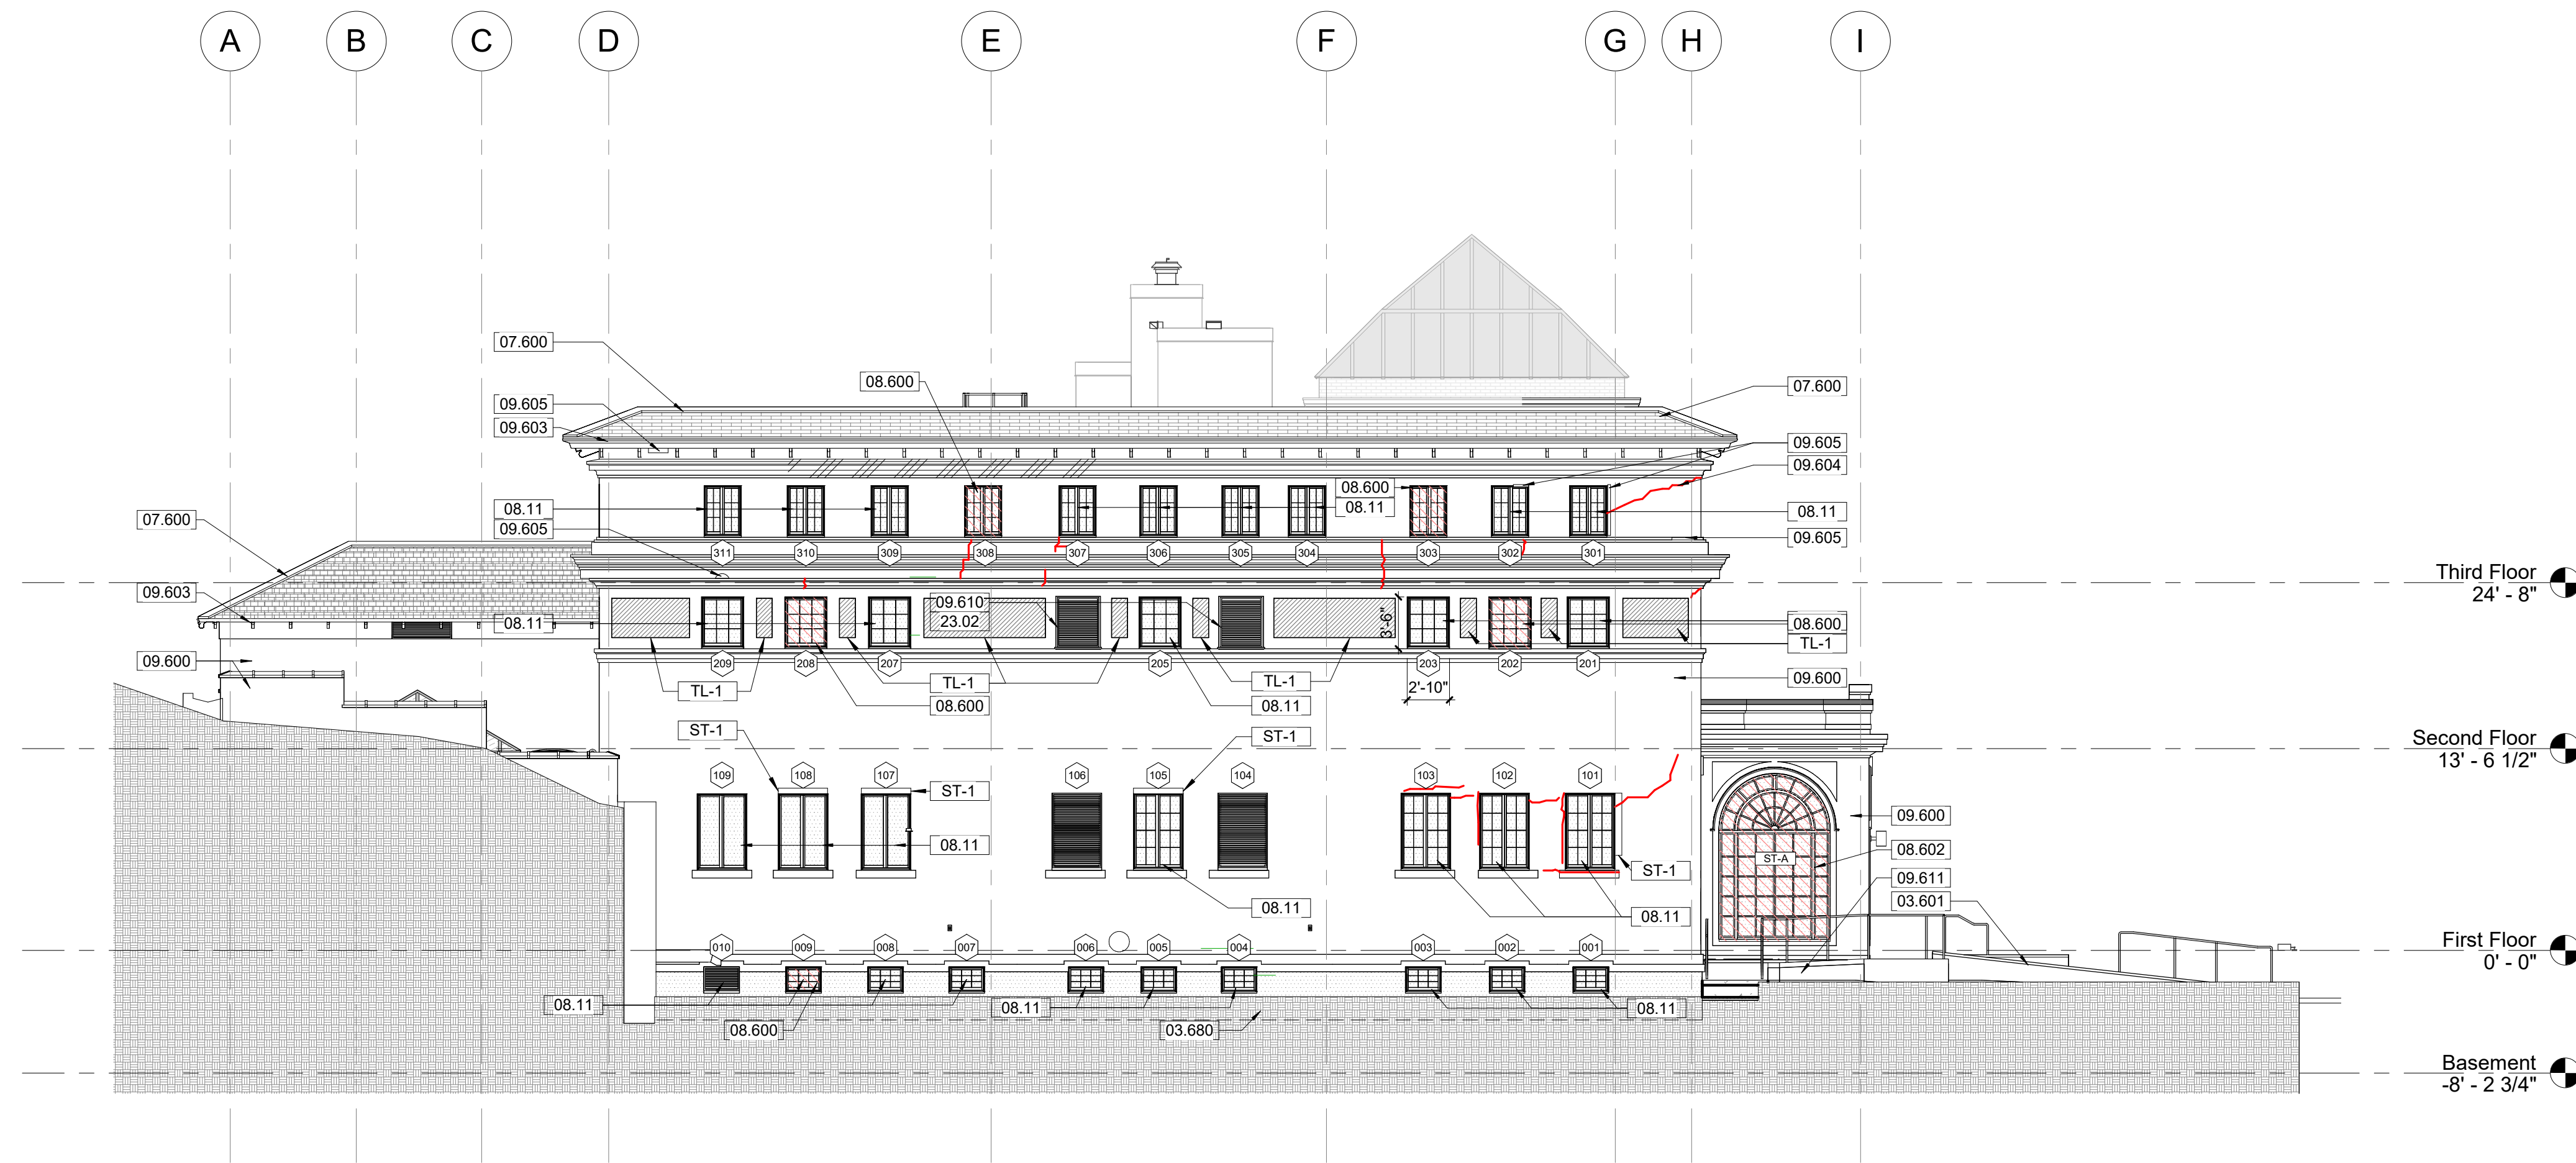
03.601	033000, 030130.52 - REPAIR CONCRETE RAMP WHERE EXISTING HANDRAILS WERE DEMOLISHED. CONCRETE PATCH TO BE FLUSH WITH EXISTING RAMP CONCRETE. REFERENCE STRUCTURAL DRAWINGS.

03.680	033000 - INSTALL NEW CONCRETE RUNNELS. REFERENCE CIVIL DRAWINGS.
07.600	REFERENCE ROOF PLAN FOR TREATMENT RECOMMENDATIONS. TYPICAL.
08.11	080152.61, 099113, 099123 - RESTORE HISTORIC WOOD WINDOW. REFERENCE WINDOW SCHEDULE FOR REQUIRED REPAIRS. PREP, PRIME, AND PAINT ALL EXISTING WOOD WINDOW TO REMAIN. INSTALL NEW EXTERIOR STORM WINDOW. REFERENCE WINDOW SCHEDULE.

08.600	088000, 099113, 099123 - INSTALL REPLICA WOOD WINDOW. REFERENCE WINDOW SCHEDULE. PREP, PRIME, AND PAINT. INSTALL NEW INTERIOR STORM WINDOW. REFERENCE WINDOW SCHEDULE.

08.602	092300, 092400 - PREP EXISTING WINDOW OPENING FOR NEW CUSTOM STEEL WINDOWS TO MATCH THE HISTORIC CONDITION AT SUN PORCH. DAMAGED INTERIOR PLASTER AND EXTERIOR STUCCO DURING INSTALL SHALL BE REPAIRED IN KIND.

09.600	099113 - PREP AND PAINT EXTERIOR WALLS (ROUGHLY 2050 SF).
09.603	062013, 099113 - REPAIR EAVES. PREP, PRIME, AND PAINT.
09.604	092400 - REPAIR CRACKS IN STUCCO (ROUGHLY 300 LF).

09.605	092400 - INSTALL NEW STUCCO WHERE LOOSE STUCCO WAS REMOVED (ROUGHLY 300 SF)
09.610	099113 - PREP, PRIME, AND PAINT NEW AND EXISTING LOUVERS.
09.611	099113 - PREP, PRIME, AND PAINT OUTSIDE FACE OF ABA RAMP TO MATCH EXISTING. ENSURE REPLACEMENT CONCRETE HAS CURED PRIOR TO PAINTING.
