A/E FIRMS PRIME/ARCH: STRATA ARCHITECTURE 1701 OAK STREET, SUITE 100 KANSAS CITY, MO T: 816.474.0900	DESIGNED: CA/AG	SUB SHEET NO. <h1>01</h1> <h1>A5.1</h1>	TITLE OF SHEET MAURICE BATHHOUSE VERTICAL CIRCULATION REHABILITATE BATHHOUSES HOT SPRINGS NATIONAL PARK	DRAWING NO. 128 182951
	CADD: CA/ZA/EM			PMIS/PKG NO. 318915
	TECH. REVIEW: AG			SHEET 65 OF 286
	DATE: 10.27.2023

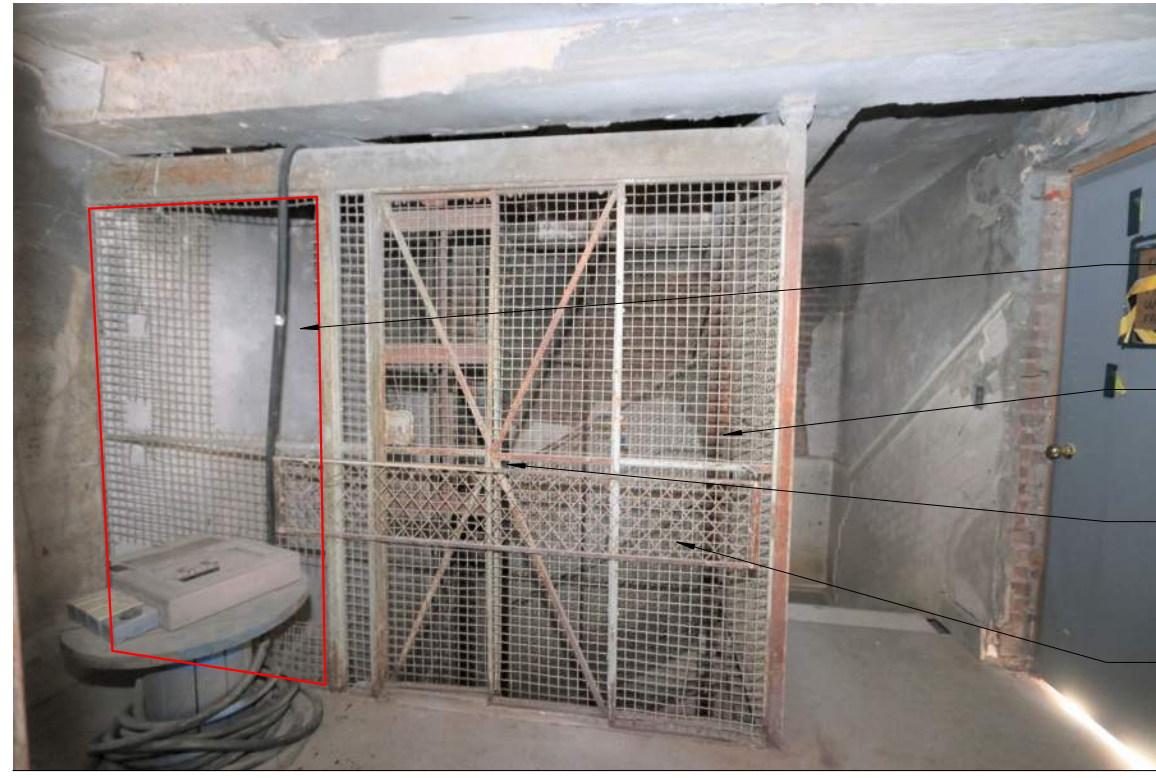
1 Photo Detail - Women's Elevator Hall 301 - Top Landing Looking South
A5.1

05.12
05.00
05.13
05.14

05.12	099123 - REPLACE DAMAGED METAL MESH IN KIND. NEW MESH SHOULD SPAN FROM METAL FRAME TO METAL FRAME (A FULL SHEET). NEW MESH TO MATCH EXISTING IN SPACING, MATERIAL, AND GAUGE. PREP, PRIME, AND PAINT. REUSE EXISTING FRAME. ATTACH PANEL MESH PANEL TO MATCH EXISTING ATTACHMENT.

05.13	EXISTING ELEVATOR DOOR AT ALL FLOORS IS TO BE SECURED AND WELDED SHUT.
05.14	024296 - REMOVE METAL PANELING SECURED TO THE EXISTING ELEVATOR CAGE THAT IS NOT ORIGINAL TO THE CAGE.

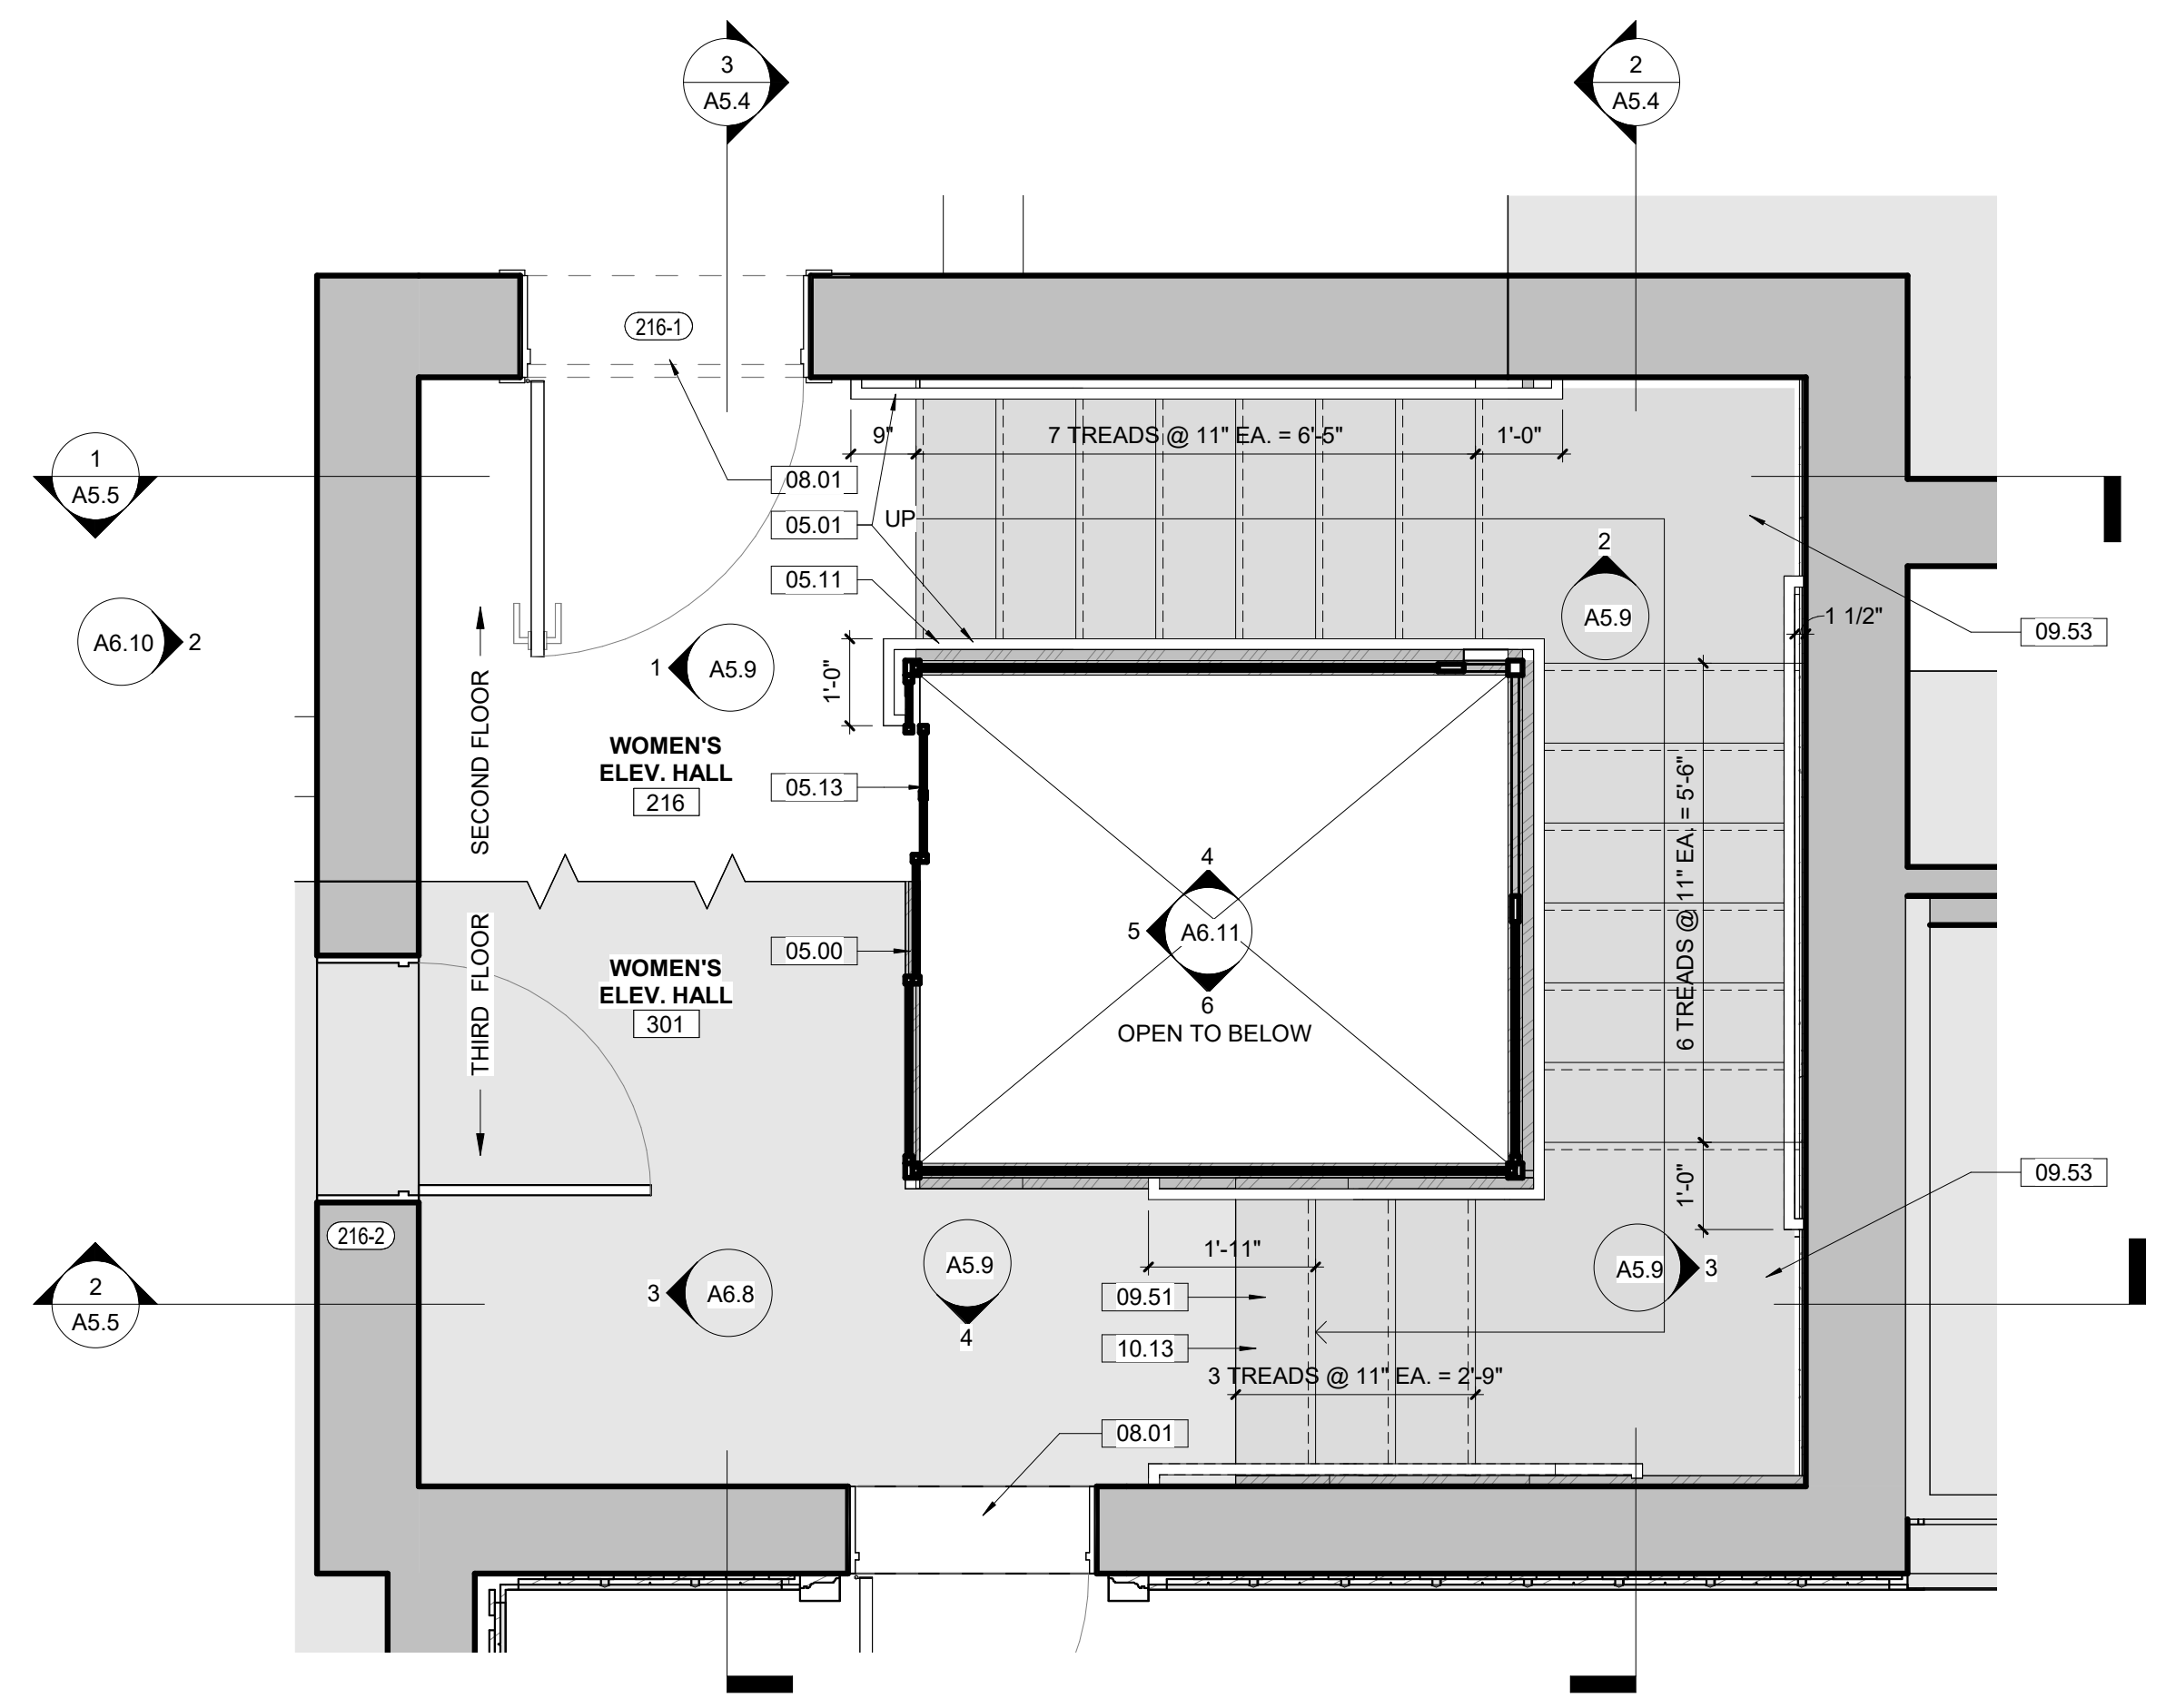
2 Enlarged Plan - North Stair Second Floor Plan
A5.1 1/2" = 1'-0" SCALE (A)

05.00	055213, 099123 - NORTH/SOUTH STAIRS: STRIP AND REPAINT EXISTING HISTORIC ELEVATOR CAGE TO REMAIN (ALL LEVELS - BASEMENT THROUGH 3RD FLOOR). PAINT WITH COLOR FROM HISTORIC PAINT ANALYSIS. MAKE REPAIRS TO ELEVATOR CAGE FOR SAFETY. REFERENCE VERTICAL CIRCULATION INTERIOR ELEVATION. REFER TO MATERIALS TEST REPORT FOR LEAD PAINT TESTING.

05.01	055213, 099123 - NORTH/SOUTH STAIRS: INSTALL METAL SUPPORT AT EXISTING ELEVATOR CAGE TO SUPPORT ANCHORING ON NEW HANDRAIL BRACKETS. PREP, PRIME, AND PAINT.

05.11	055213, 099123 - NORTH/SOUTH STAIR: INSTALL NEW ABAAS COMPLIANT STEEL HANDRAIL AT ALL LEVELS - BASEMENT THROUGH 3RD FLOOR. PREP, PRIME AND PAINT IN THE FIELD. ALL ANCHORS TO BE STAINLESS STEEL.

08.01	081113, 081433, 087100 - REFERENCE FLOOR PLANS, THE DOOR SCHEDULE, AND SPECIFICATIONS FOR WORK REQUIRED FOR DOORS.
08.51	NORTH STAIRS: REPLACE MISSING MARBLE TREADS. START THE REPLACEMENT WITH THE 17 NON-HISTORIC MARBLE TREADS STORED IN MEN'S DRESSING ROOM 205. USE THE 10 HISTORIC MARBLE TREADS STORED IN WOMEN'S PACK ROOM 101 AND 12 HISTORIC MARBLE TREADS STORED IN HALL 211 TO FILL IN. ALL MARBLE TREADS TO BE CLEANED WITH BASIS OF DESIGN PROSOCO LIQUID MARBLE CLEANER, OR EQUAL, PER THE MANUFACTURER'S INSTRUCTIONS. REMOVE STAINING AND SOILING FROM MARBLE.

09.53	NORTH STAIRS: REPLACE LANDINGS WITH MARBLE LANDINGS STORED IN WOMEN'S PACK ROOM 101, MEN'S DRESSING ROOM 205, AND HALL 211. INSTALL 3 NEW MARBLE LANDINGS TO MATCH EXISTING. MISSING MARBLE LANDINGS ARE ROUGHLY 42-INCHES BY 42-INCHES. FIELD MEASURE LANDINGS FOR FINAL DIMENSIONS FOR NEW REPLACEMENT LANDINGS. ALL MARBLE LANDINGS TO BE CLEANED WITH BASIS OF DESIGN PROSOCO LIQUID MARBLE CLEANER, OR EQUAL, PER THE MANUFACTURER'S INSTRUCTIONS. REMOVE STAINING AND SOILING FROM MARBLE.

10.13	ADD ABA TEXTURED LOW VISION ANTI-SLIP TAPE ALONG TREAD EDGE. TYPICAL FOR ALL INTERIOR STAIRS.
