**HISTORIC ELEVATOR STABILIZATION WORK:**

A/E FIRMS PRIME/ARCH: STRATA ARCHITECTURE 1701 OAK STREET, SUITE 100 KANSAS CITY, MO T: 816.474.0900	DESIGNED: CA/AG	SUB SHEET NO.  <b>01</b> <b>A5.2</b>	TITLE OF SHEET MAURICE BATHHOUSE <b>VERTICAL CIRCULATION</b>	DRAWING NO. <b>128</b> <b>182951</b>
	CADD: CA/ZA/EM		PMIS/PKG NO. 318915	
	TECH. REVIEW: AG		SHEET 66 OF 286	
	DATE: 10.27.2023		REHABILITATE BATHHOUSES HOT SPRINGS NATIONAL PARK

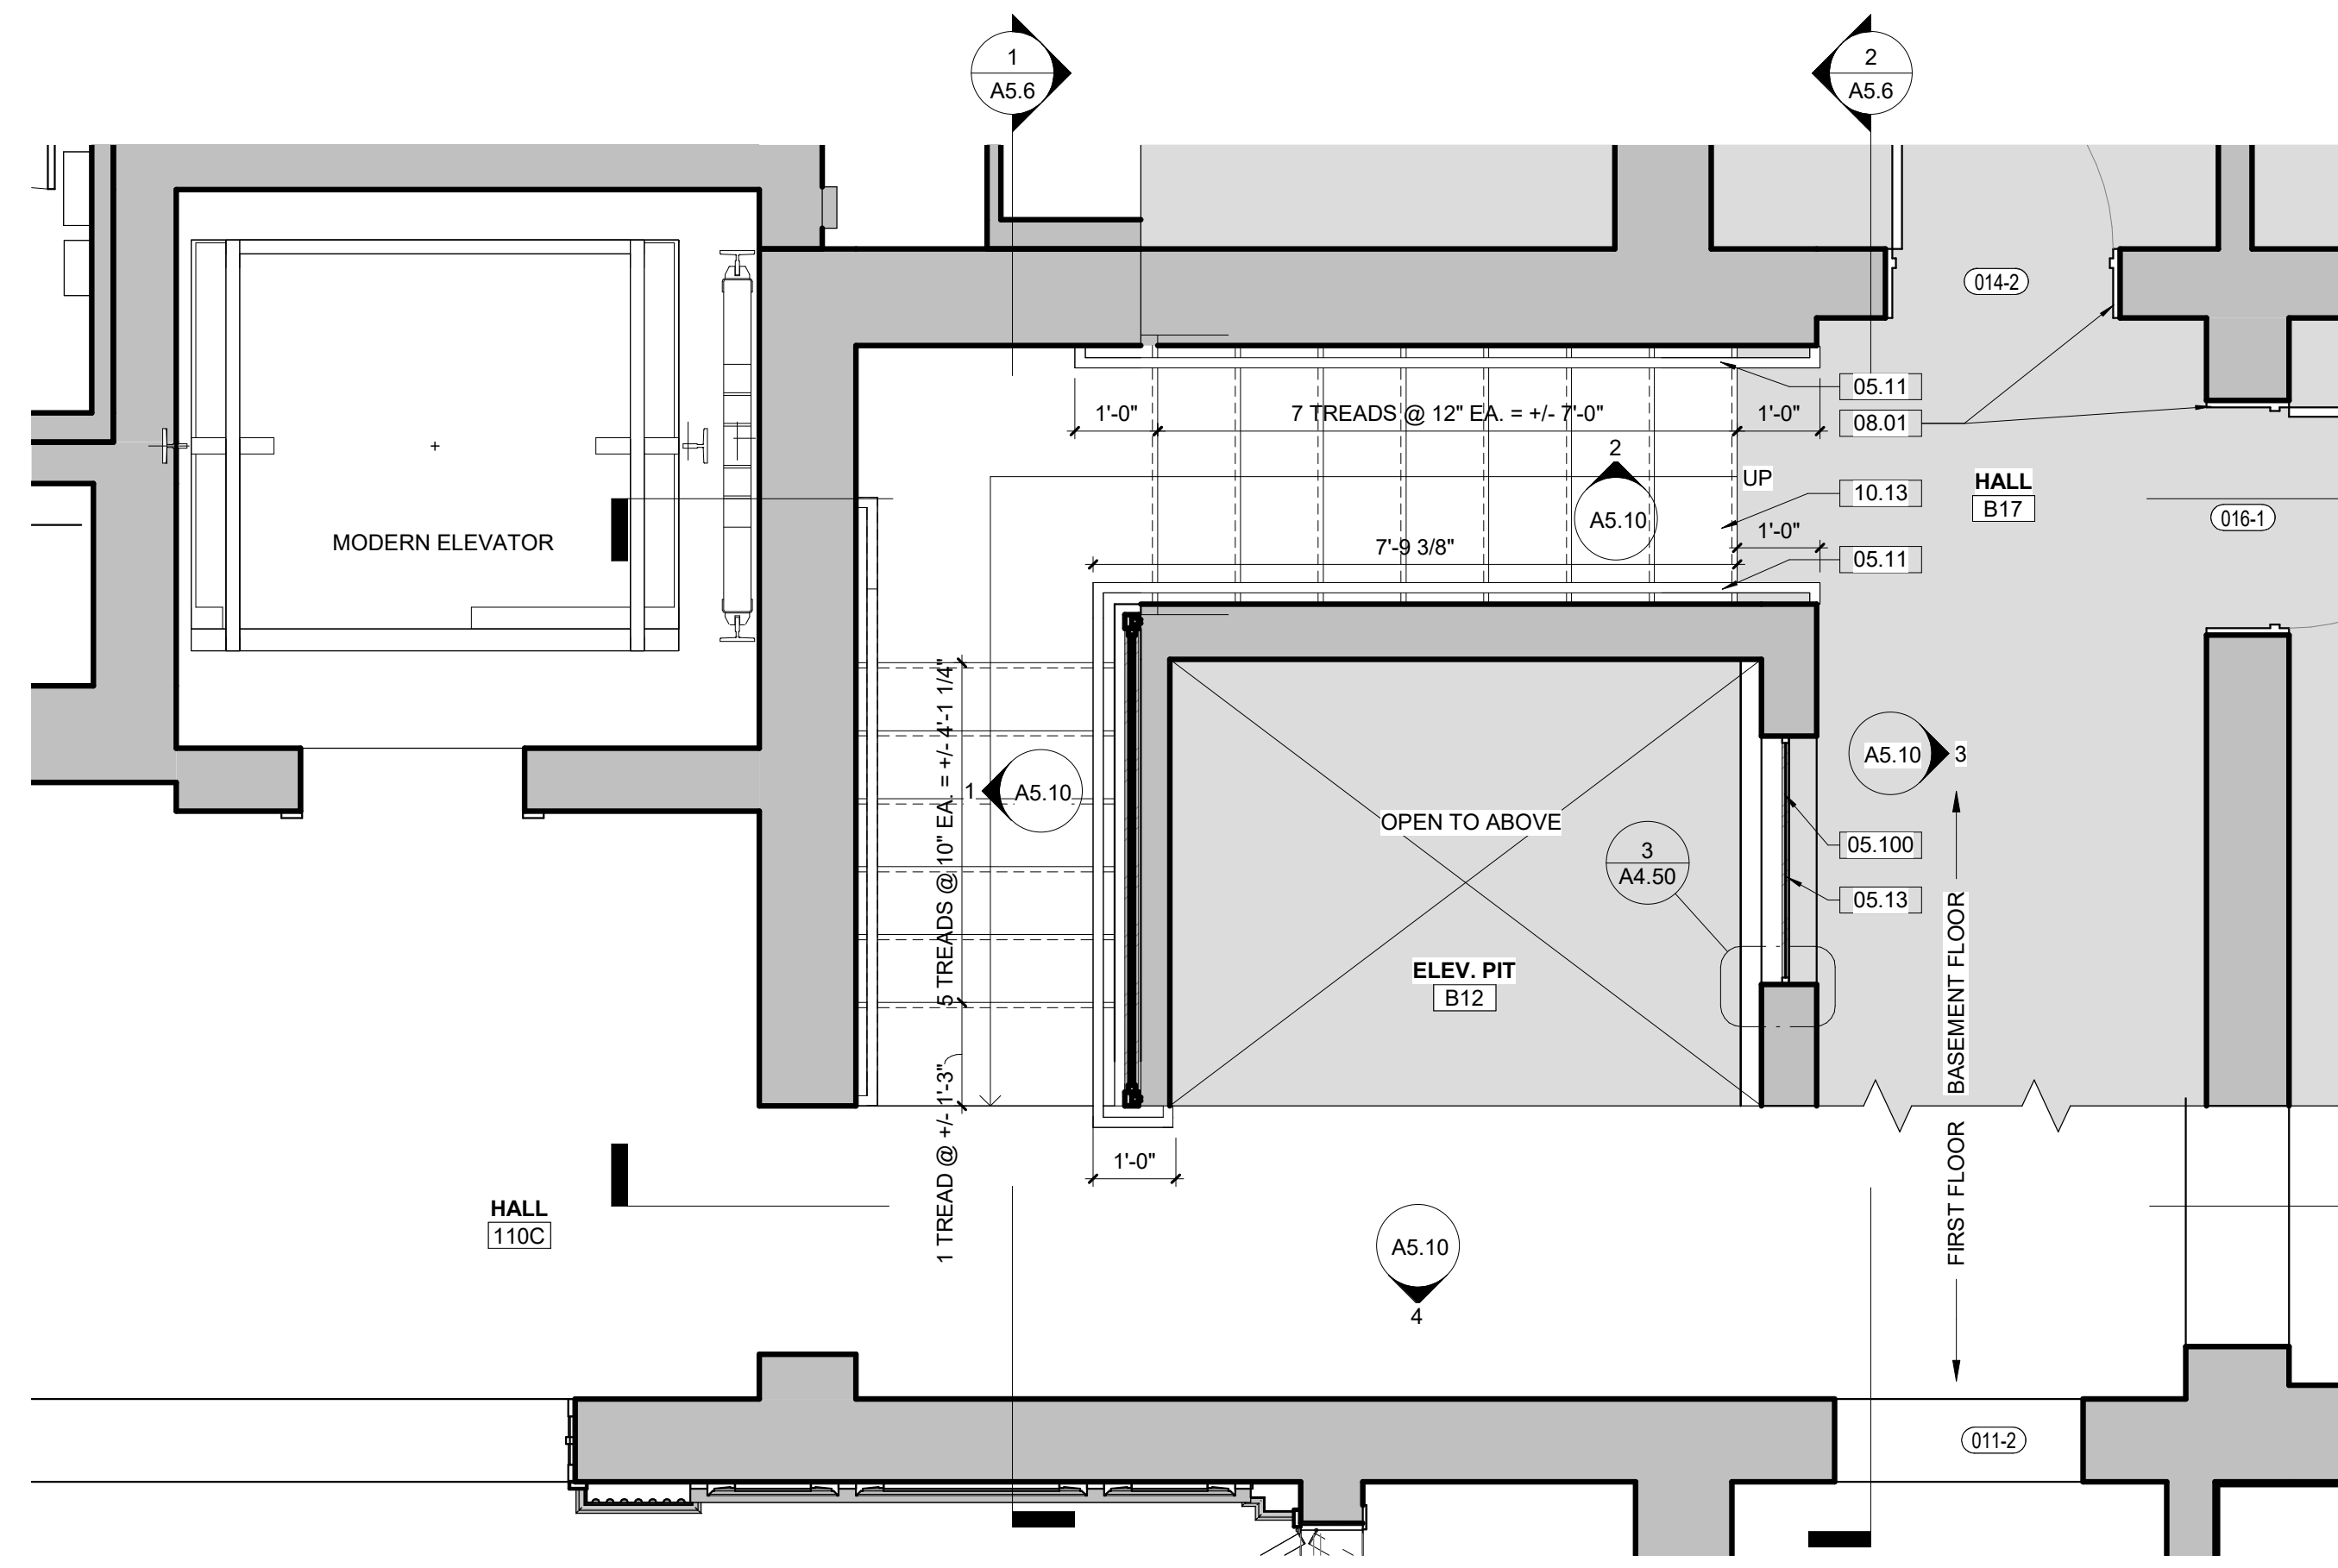
**1**  
**A5.2** Enlarged Plan - South Stairs and Elevator Basement Plan  
1/2" = 1'-0" SCALE (A)

EXISTING HISTORIC WIRE CAGE ELEVATORS IN MEN'S AND WOMEN'S STAIR HALLS TO BE STABILIZED BY CONTRACTOR. CABS TO BE MOVED AND STABILIZED AT THE FIRST FLOOR LEVEL AND FULLY SUPPORTED WITH STEEL BEAM TO NOT MOVE. WEIGHTS TO BE DISENGAGED AND FIXED IN PLACE. CABLES TO BE DISCONNECTED AND INSTALLED TO BE NON-WORKING AND FIXED IN PLACE. CONTRACTOR TO CLEAN UP ALL DEBRIS AND LOOSE EQUIPMENT OR PARTS FROM ELEVATOR PITS. ALL PARTS TO BE BOXED, LABELED, AND DELIVERED TO PARK STORAGE. CONTRACTOR TO EMPTY ALL OIL FROM MOTORS, IF EXISTING. SLIDING DOORS TO BE WELDED INTO PLACE AT ALL FLOOR LEVELS TO PREVENT ACCESS INTO SHAFT. ALL SECTIONS OF THE SHAFT WIRE CAGE TO BE REPAIRED WITH SECTIONS OF NEW METAL MESH PANELING WHERE WIRE MESH IS MISSING OR DAMAGED.

05.00	055213, 099123 - NORTH/SOUTH STAIRS: STRIP AND REPAINT EXISTING HISTORIC ELEVATOR CAGE TO REMAIN (ALL LEVELS - BASEMENT THROUGH 3RD FLOOR). PAINT WITH COLOR FROM HISTORIC PAINT ANALYSIS. MAKE REPAIRS TO ELEVATOR CAGE FOR SAFETY. REFERENCE VERTICAL CIRCULATION INTERIOR ELEVATION. REFER TO MATERIALS TEST REPORT FOR LEAD PAINT TESTING.

05.01	055213, 099123 - NORTH/SOUTH STAIRS: INSTALL METAL SUPPORT AT EXISTING ELEVATOR CAGE TO SUPPORT ANCHORING ON NEW HANDRAIL BRACKETS. PREP, PRIME, AND PAINT.

05.11	055213, 099123 - NORTH/SOUTH STAIR: INSTALL NEW ABAAS COMPLIANT STEEL HANDRAIL AT ALL LEVELS - BASEMENT THROUGH 3RD FLOOR. PREP, PRIME AND PAINT IN THE FIELD. ALL ANCHORS TO BE STAINLESS STEEL.

05.13	EXISTING ELEVATOR DOOR AT ALL FLOORS IS TO BE SECURED AND WELDED SHUT.
05.100	BASEMENT: INSTALL NEW METAL GATE AT ELEVATOR PIT OPENINGS (2 EA).
08.01	081113, 081433, 087100 - REFERENCE FLOOR PLANS, THE DOOR SCHEDULE, AND SPECIFICATIONS FOR WORK REQUIRED FOR DOORS.

09.52	SOUTH STAIRS: CLEAN ALL MARBLE TREADS AND LANDINGS (1 LS). BASIS OF DESIGN PROSOCO LIQUID MARBLE CLEANER, OR EQUAL, PER THE MANUFACTURER'S INSTRUCTIONS. REMOVE STAINING AND SOILING FROM MARBLE.

10.13	ADD ABA TEXTURED LOW VISION ANTI-SLIP TAPE ALONG TREAD EDGE. TYPICAL FOR ALL INTERIOR STAIRS.
