A/E FIRMS PRIME/ARCH: STRATA ARCHITECTURE 1701 OAK STREET, SUITE 100 KANSAS CITY, MO T: 816.474.0900	DESIGNED: CA/AG CADD: CA/ZA/EM TECH. REVIEW: AG DATE: 10.27.2023
--	---

TITLE OF SHEET MAURICE BATHHOUSE INTERIOR ELEVATIONS - 105 REHABILITATE BATHHOUSES HOT SPRINGS NATIONAL PARK	SUB SHEET NO. 01 A6.2
---	---

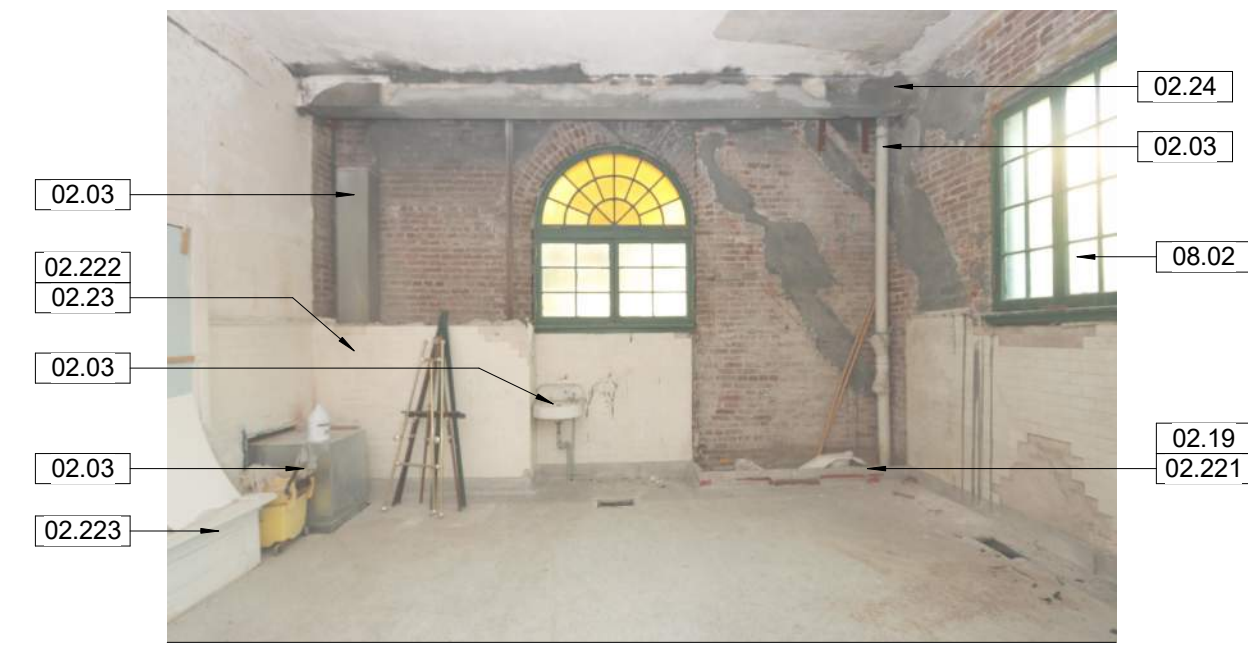
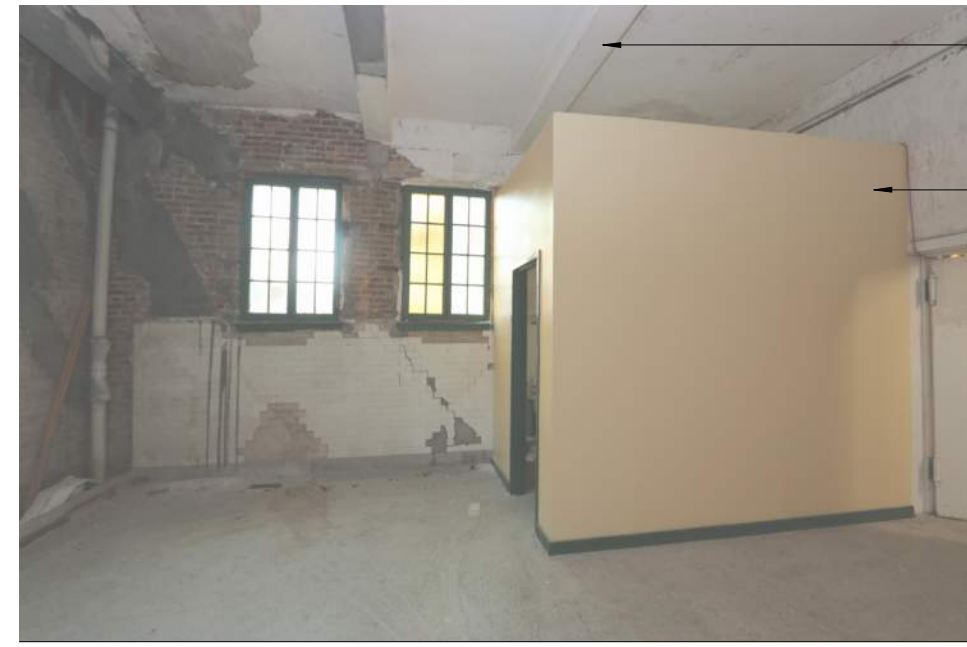
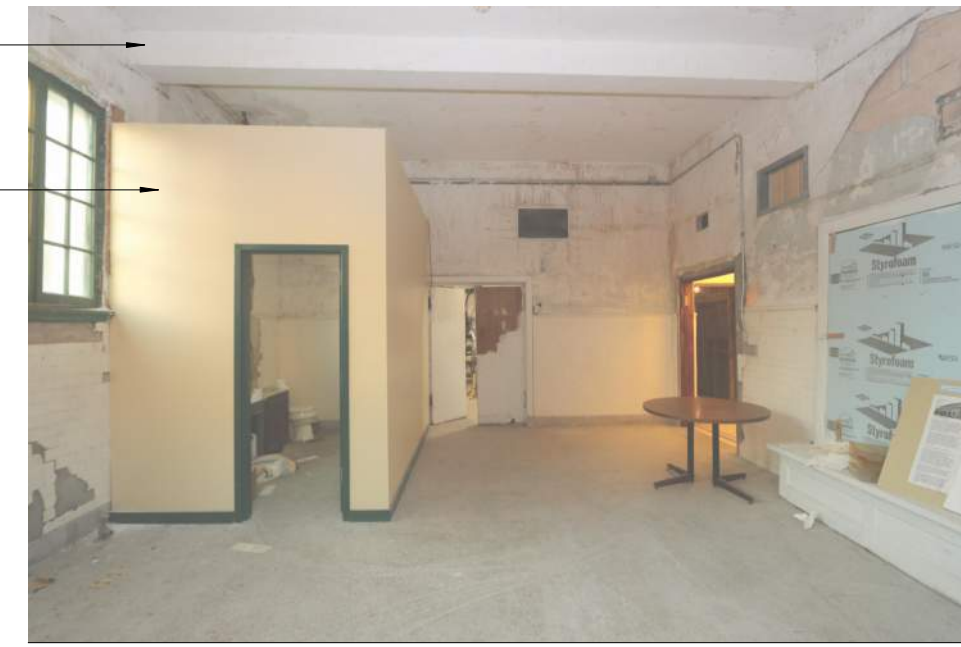
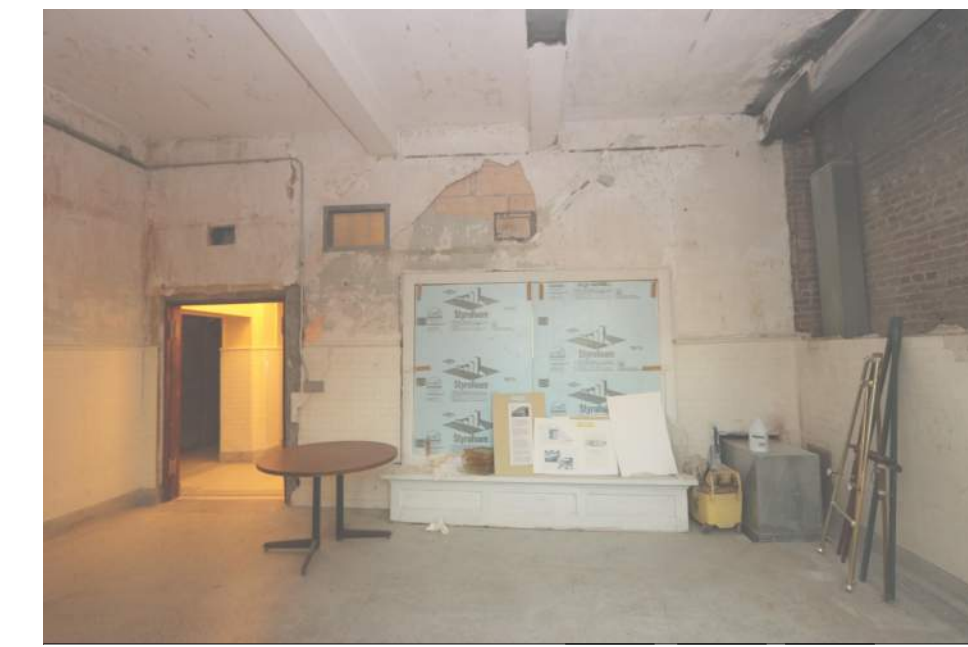
1 Photo Details - Women's Cooling 105
A6.2

WOMEN'S COOLING ROOM 105, LOOKING WEST

WOMEN'S COOLING ROOM 105, LOOKING NORTH

WOMEN'S COOLING ROOM 105, LOOKING SOUTH
