1  
S1.1A  
FIRST FLOOR REPAIR PLAN  
1/8" = 1'-0" SCALE (A)

A/E FIRMS PRIME/ARCH: STRATA ARCHITECTURE 1703 OAK STREET, SUITE 100 KANSAS CITY, MO T: 816.474.0900	DESIGNED: KH CADD: CM TECH. REVIEW: NH DATE: 10.27.2023	SUB SHEET NO. <b>01</b> <b>S1.1A</b>	TITLE OF SHEET MAURICE BATHHOUSE <b>FIRST FLOOR REPAIR PLAN</b>  REHABILITATE BATHHOUSES HOT SPRINGS NATIONAL PARK	DRAWING NO. <b>128</b> <b>182951</b> PMIS/PKG NO. 318915 97 OF 286
--	--	--	---	---

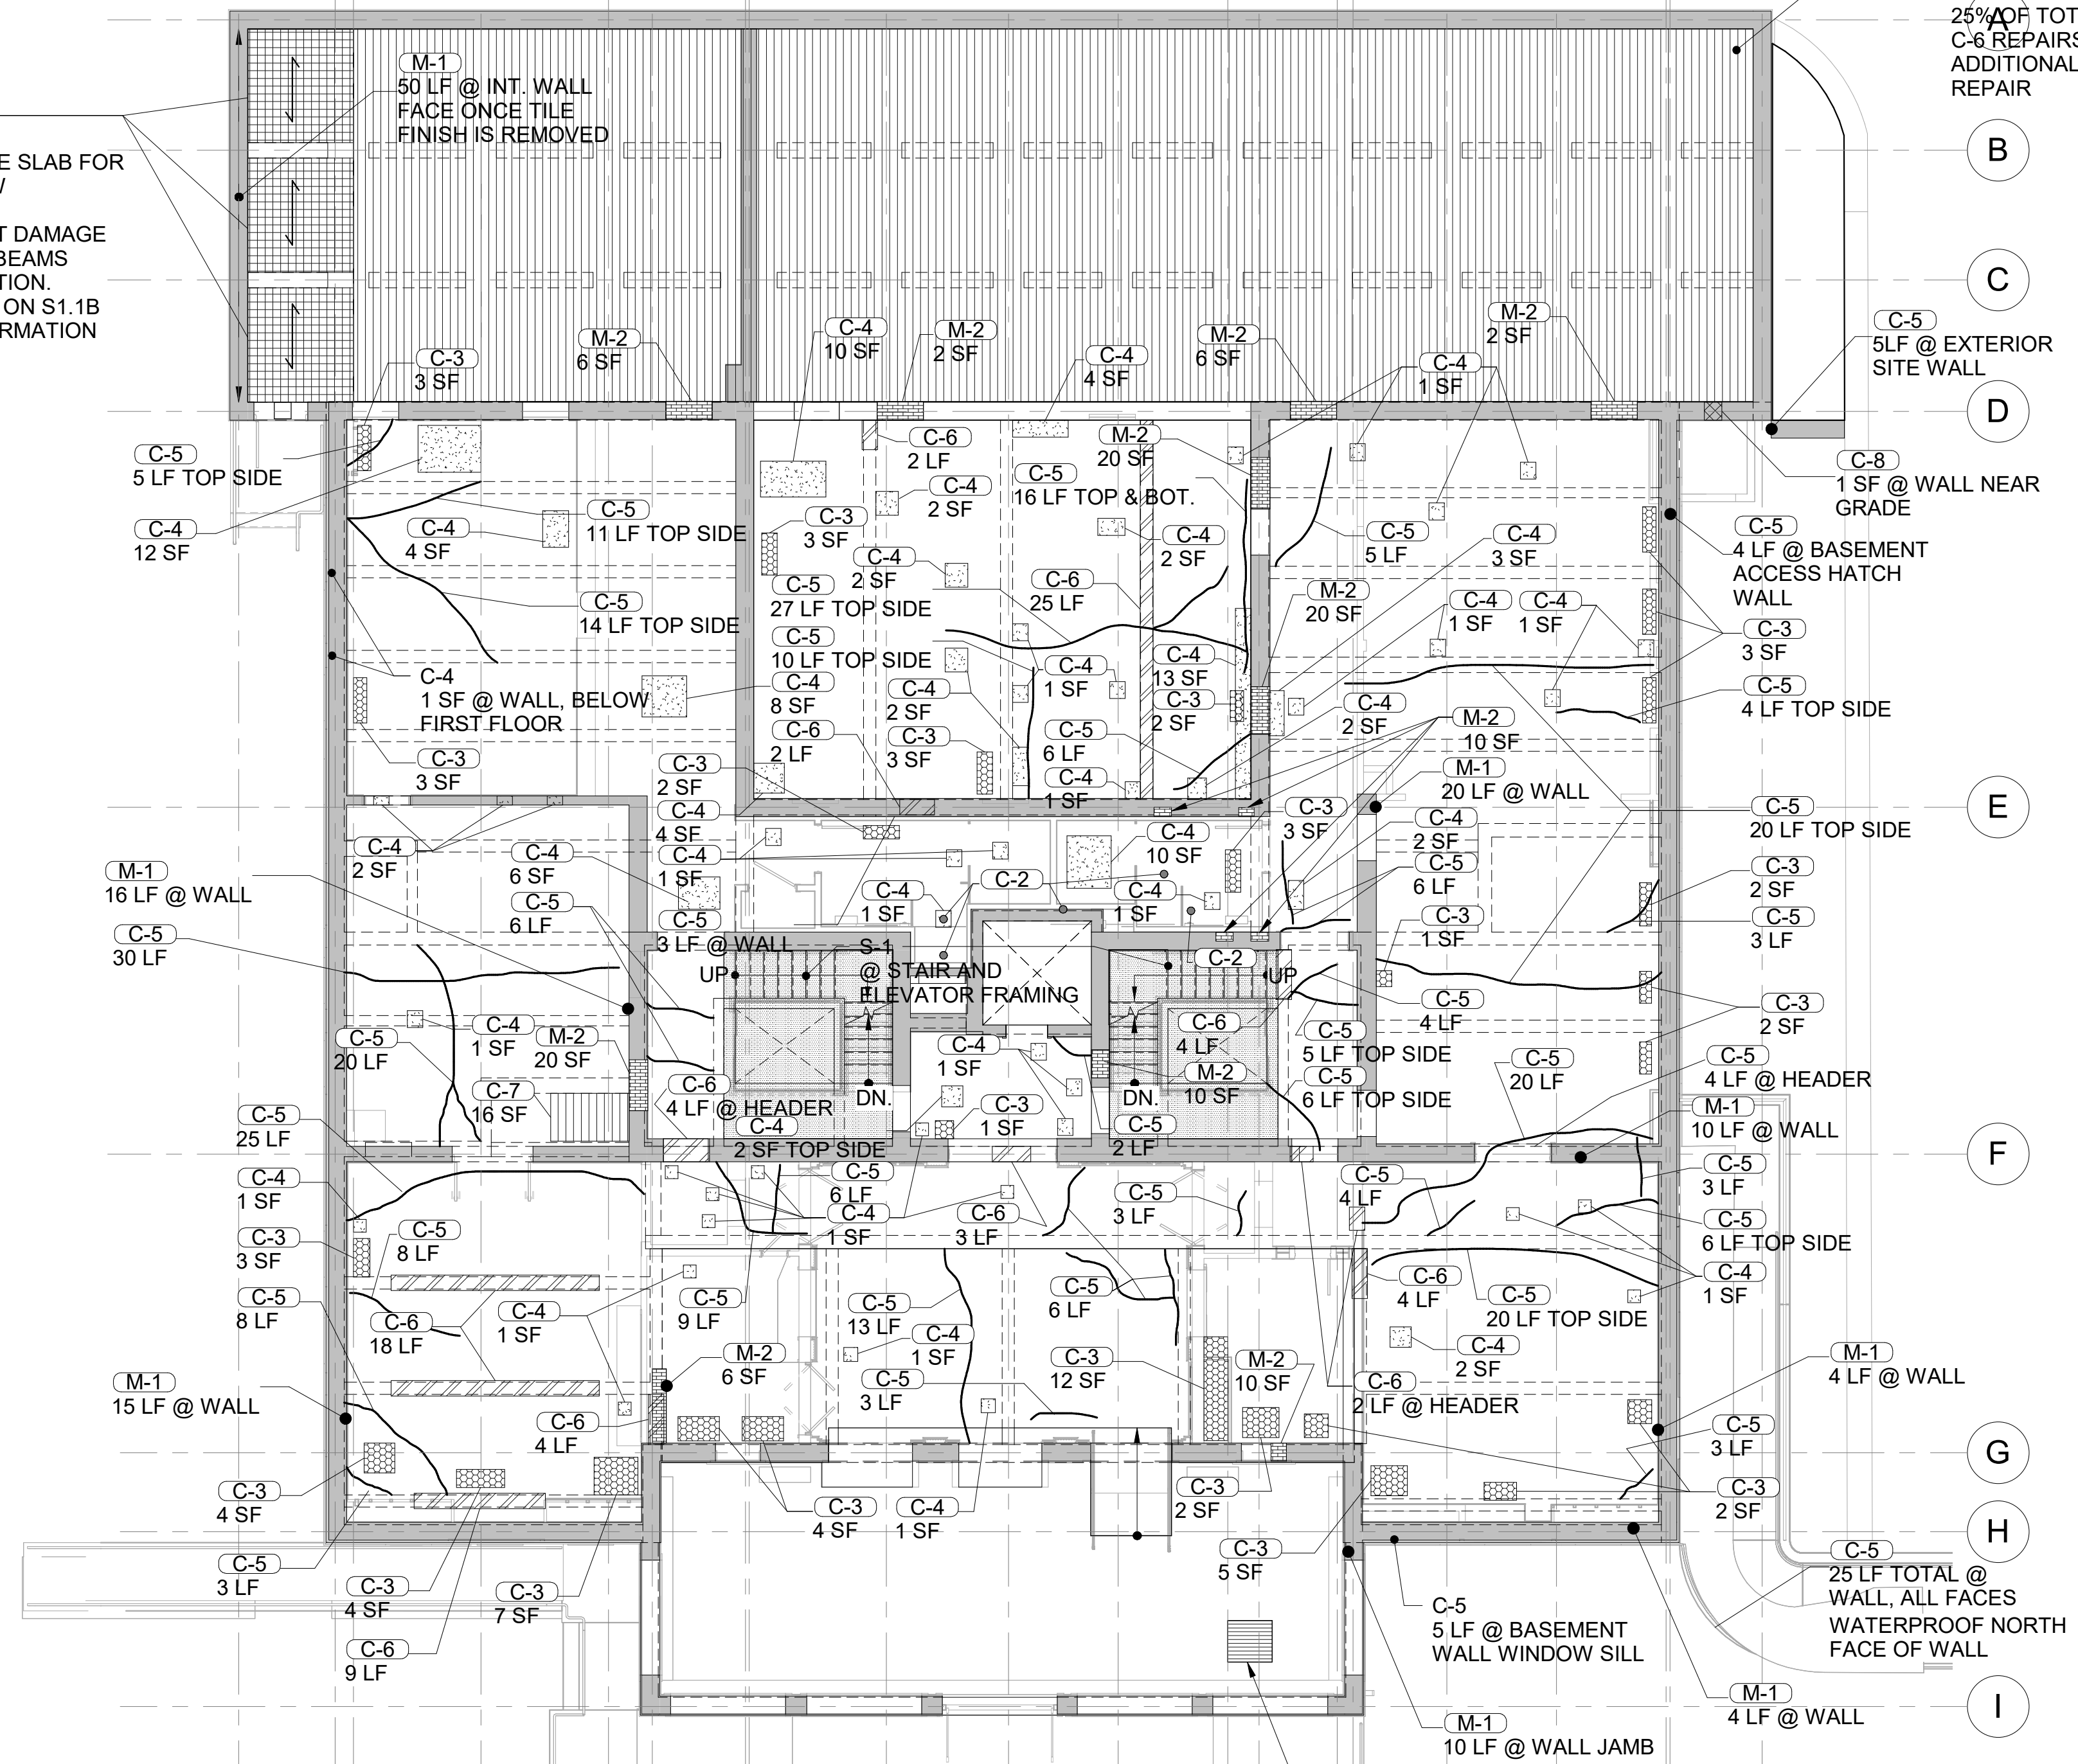
**C-7**  
152 SF TOTAL  
REMOVE AND REPLACE SLAB FOR  
INSTALLATION OF NEW  
CONCRETE WALL IN  
CRAWLSPACE. DO NOT DAMAGE  
EXISTING CONCRETE BEAMS  
DURING SLAB DEMOLITION.  
REFER TO PLAN NOTE ON S1.1B  
FOR ADDITIONAL INFORMATION

2194 SF TOTAL FOR CONCRETE FLOOR  
FRAMING ABOVE CRAWLSPACE  
(CONFINED) WITH LIMITED ACCESS AND  
LIGHTING. FOR PRICING ASSUME 20% OF  
TOTAL AREA REQUIRES C-4 REPAIRS,  
25% OF TOTAL BEAM LENGTH REQUIRES  
C-6 REPAIRS (ESTIMATED 50 LF).  
ADDITIONALLY, ASSUME 50 LF OF C-5  
REPAIR

C-1  
5 SF TOTAL WITHIN SUNPORCH  
AT DEMOLISHED PIPE  
LOCATIONS
