SIEMENS  
HEBER SPRINGS,  
ARKANSAS

FACILITY ASSESSMENT

| <b>PROJECT</b> | Siemens Power Transmission and Distribution, Inc.<br>Heber Springs, AR<br>Facility Assessment |
| <b>DATE</b> | 10/10/2025 |

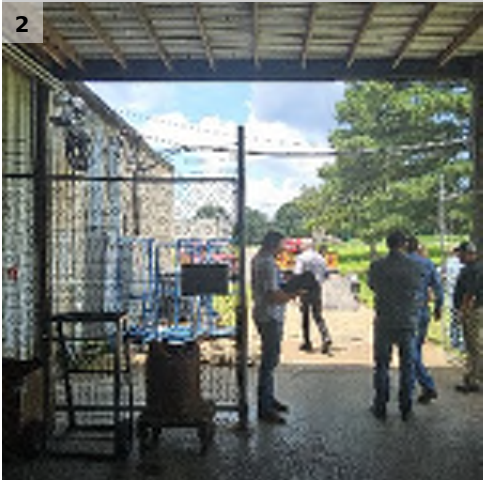
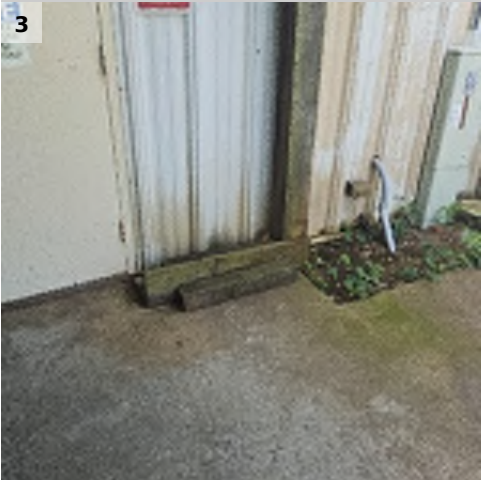
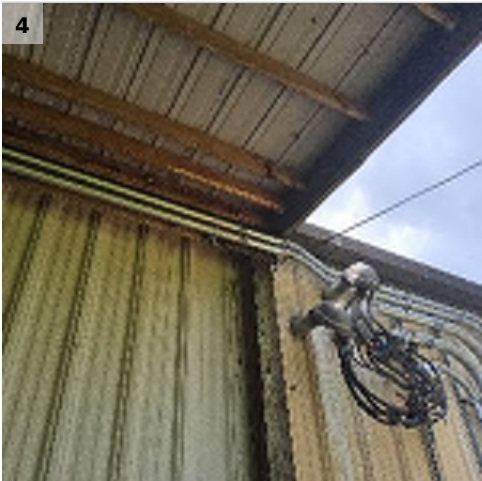
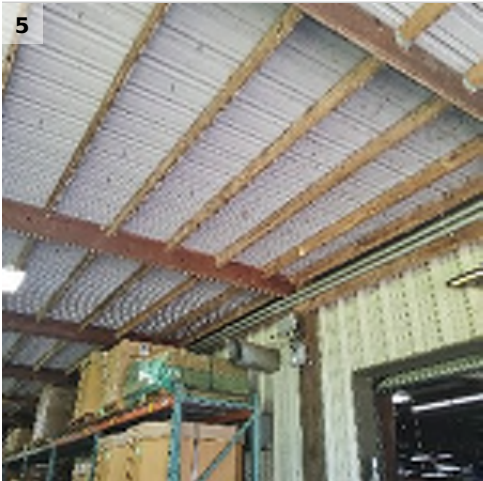
**#1 - Lean-to addition is wood-framed**

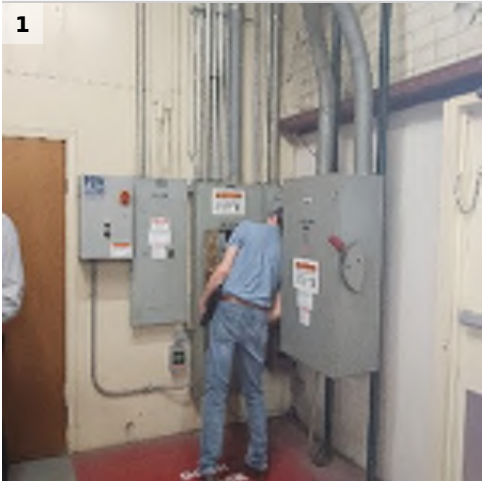
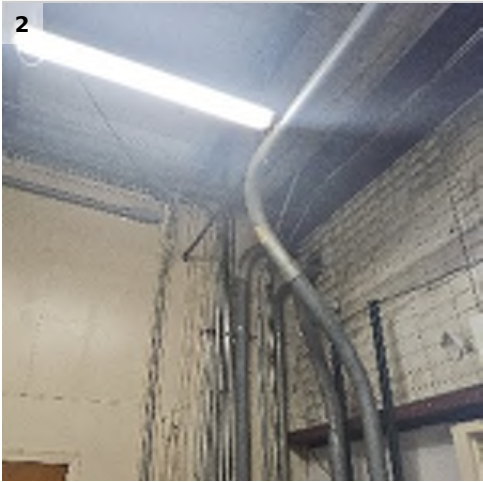
#3 - Electrical service

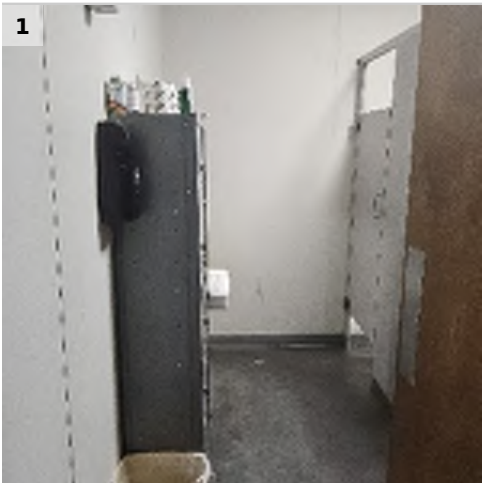
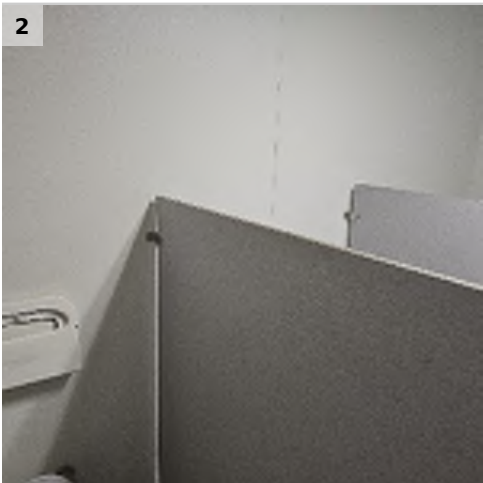
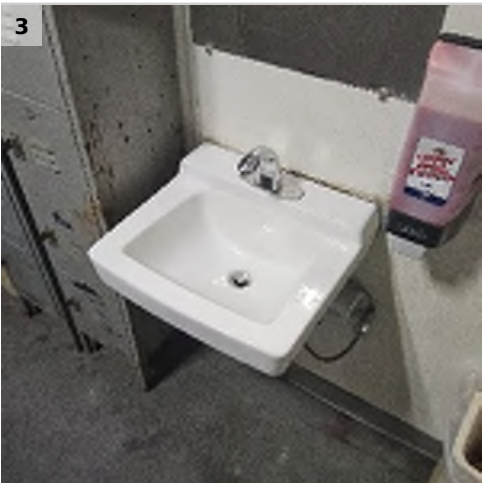
**#9 - Restroom is non compliant**

| Kennedy Lockhart | Restroom is non compliant | 24 Jun 11:11 AM |

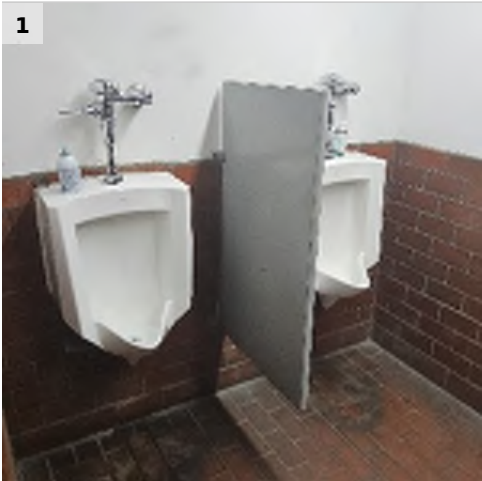
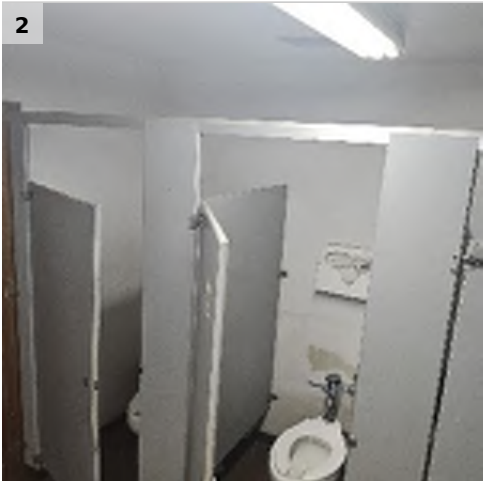
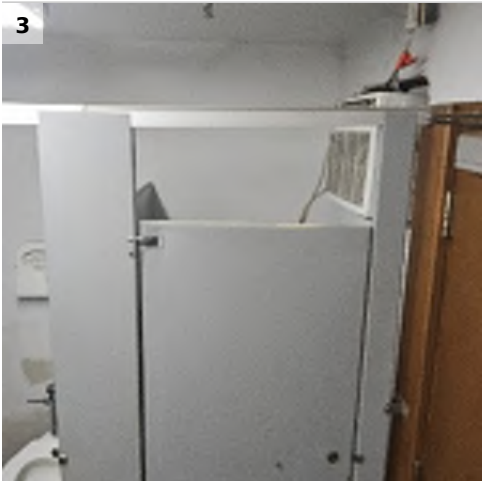
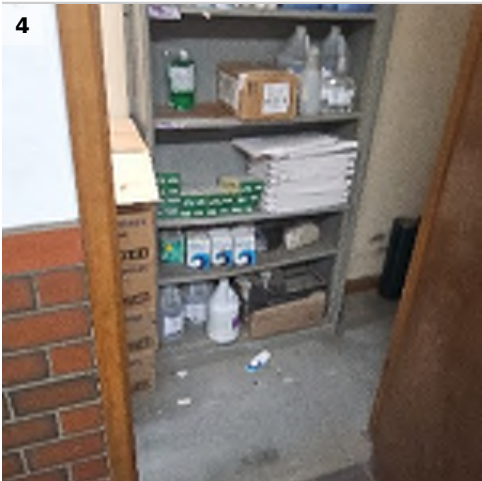
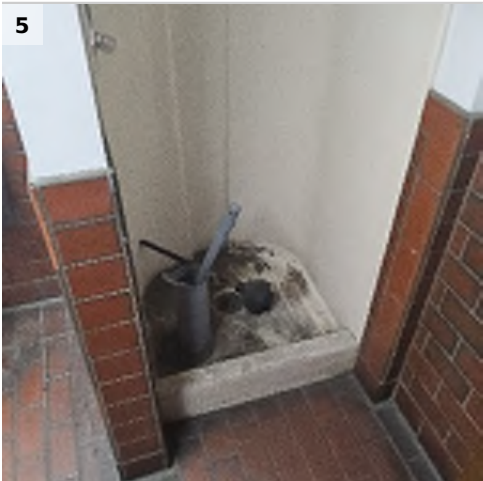
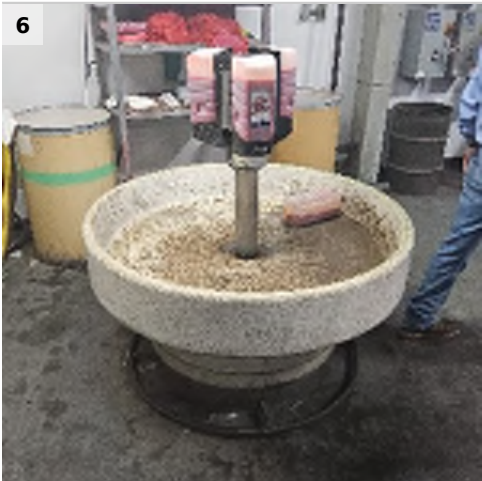
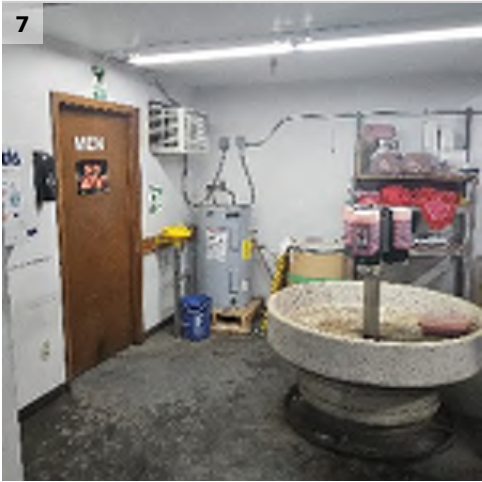
#12 - Restroom is non compliant

| Kennedy Lockhart | Restroom is non compliant | 24 Jun 11:15 AM |

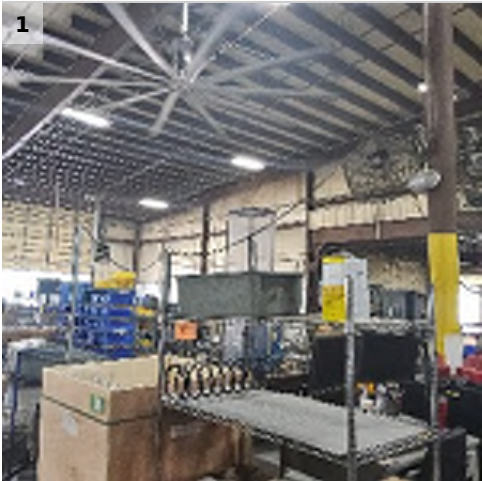
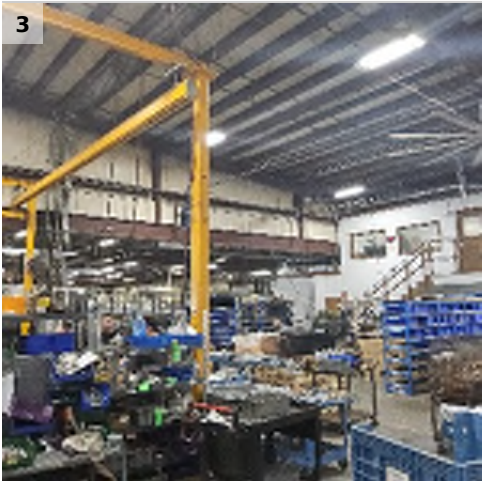
#14 - Exterior exhaust fans aren't used

| Kennedy Lockhart | HVLS fans ARE used | 27 Jun 06:38 AM |

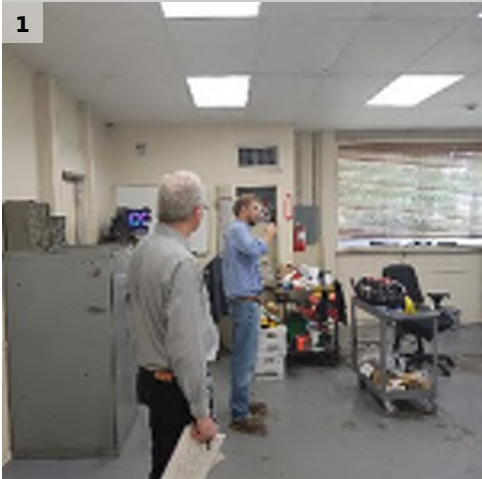
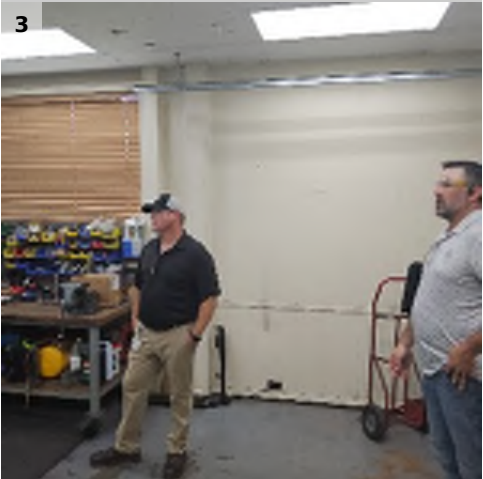
**#28 - Windows leak around seals**

| Kennedy Lockhart | Windows leak around seals | 24 Jun 12:08 PM |
